Monterey Pine subject of application

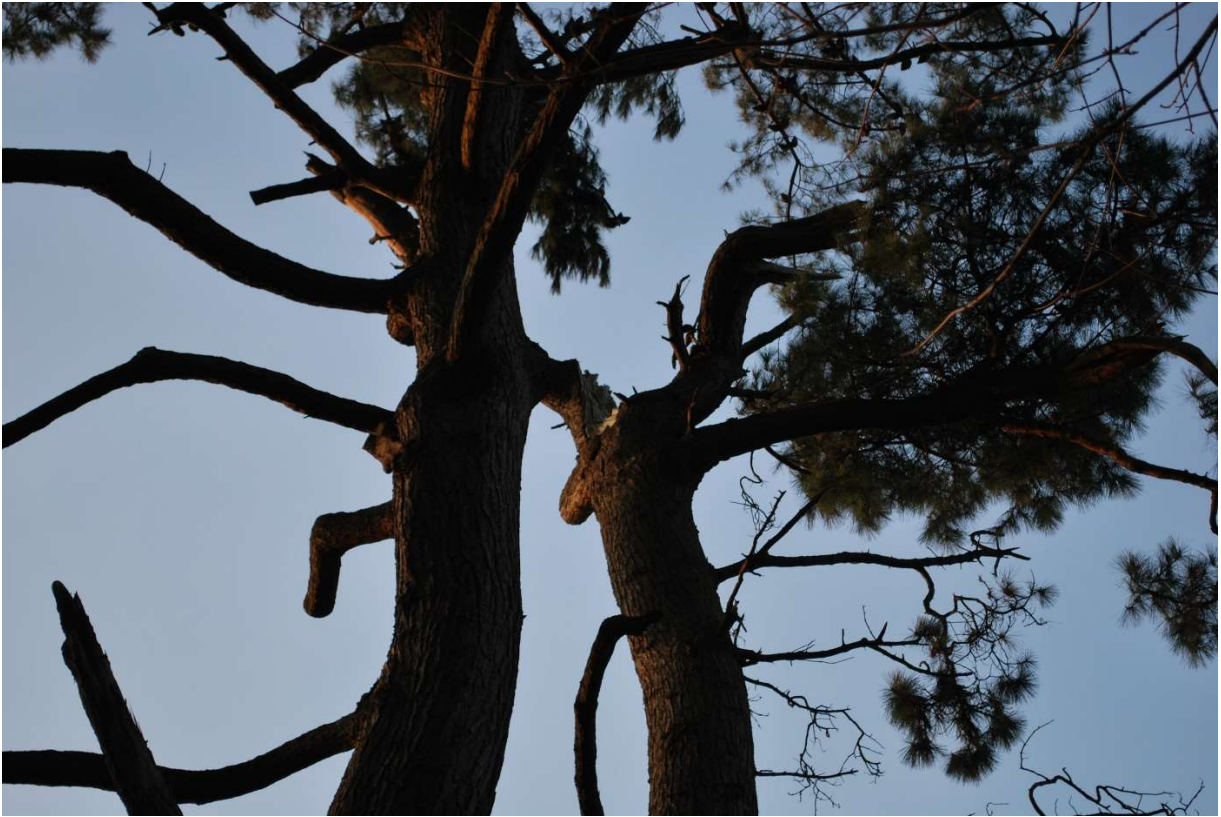
Damage in upper canopy of failure liable to fall

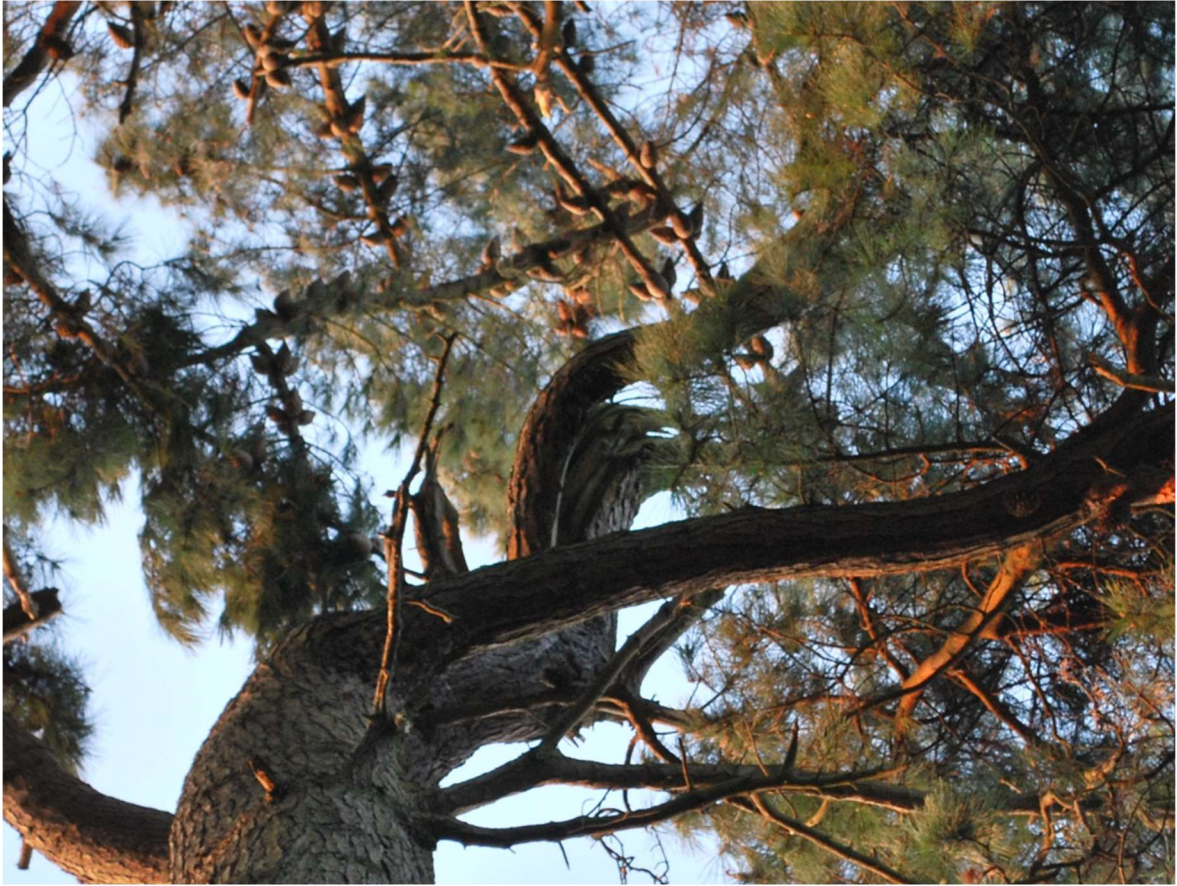
Hazard Beam formed in canopy

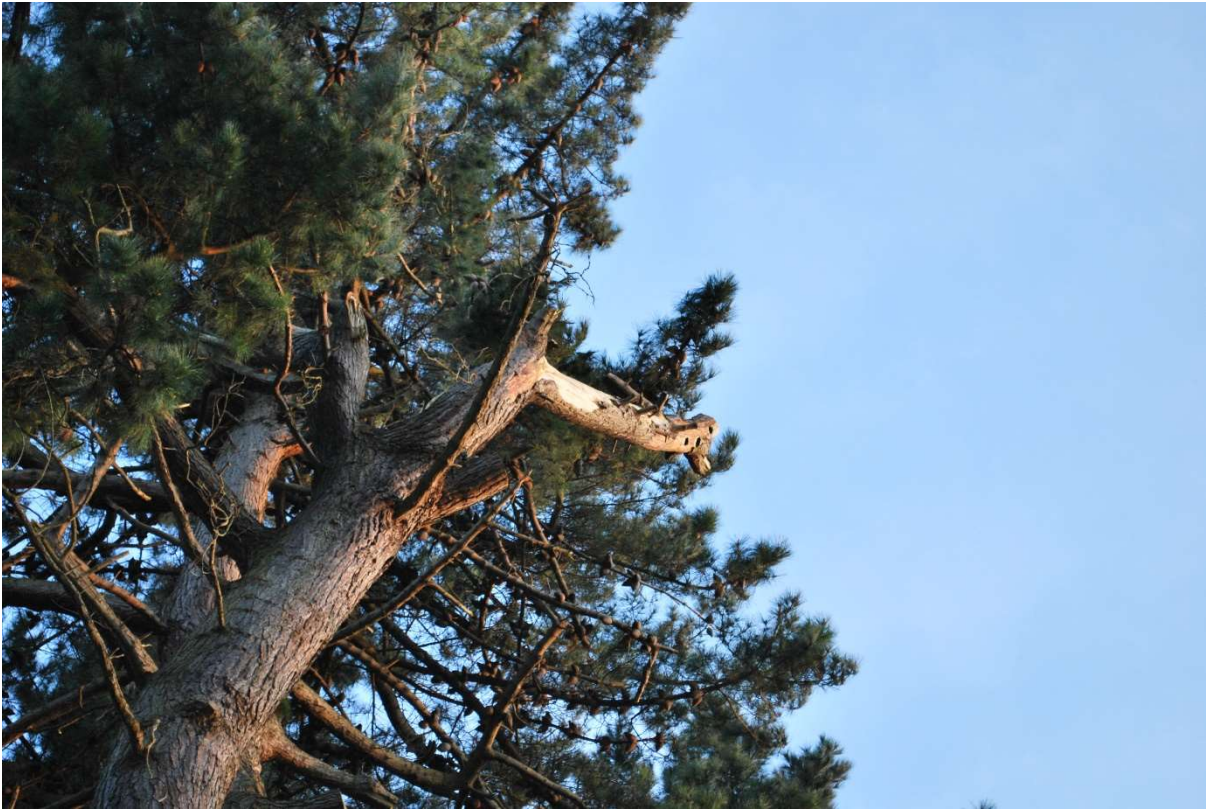
Dead section of tree causing hazard to footpath and nearby property

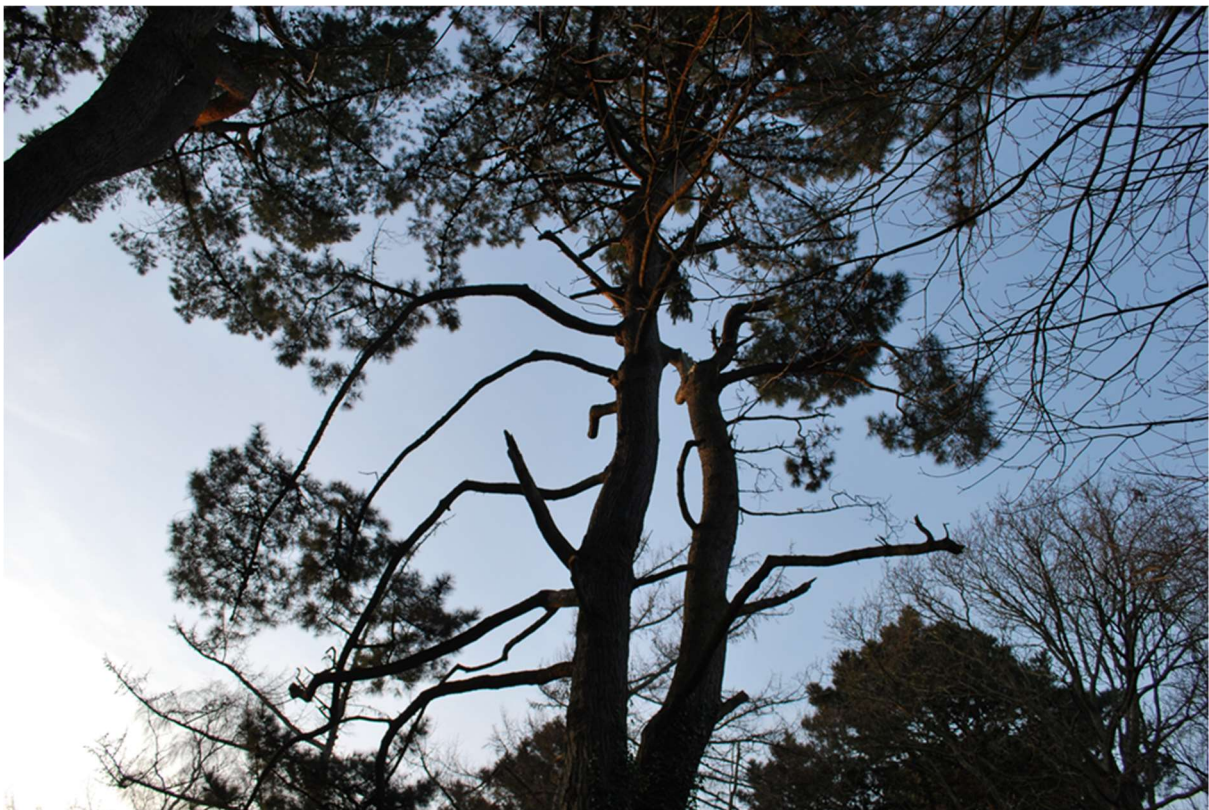
Overall poor quality of tree from past poor pruning and failures
