ARBORICULTURAL PLANNING CONSULTANTS

January 2023

Our reference: SJA hzr 22578-01

Hazard report for a Monterey pine tree (*Pinus radiata*) at Marlhill Copse, Southampton

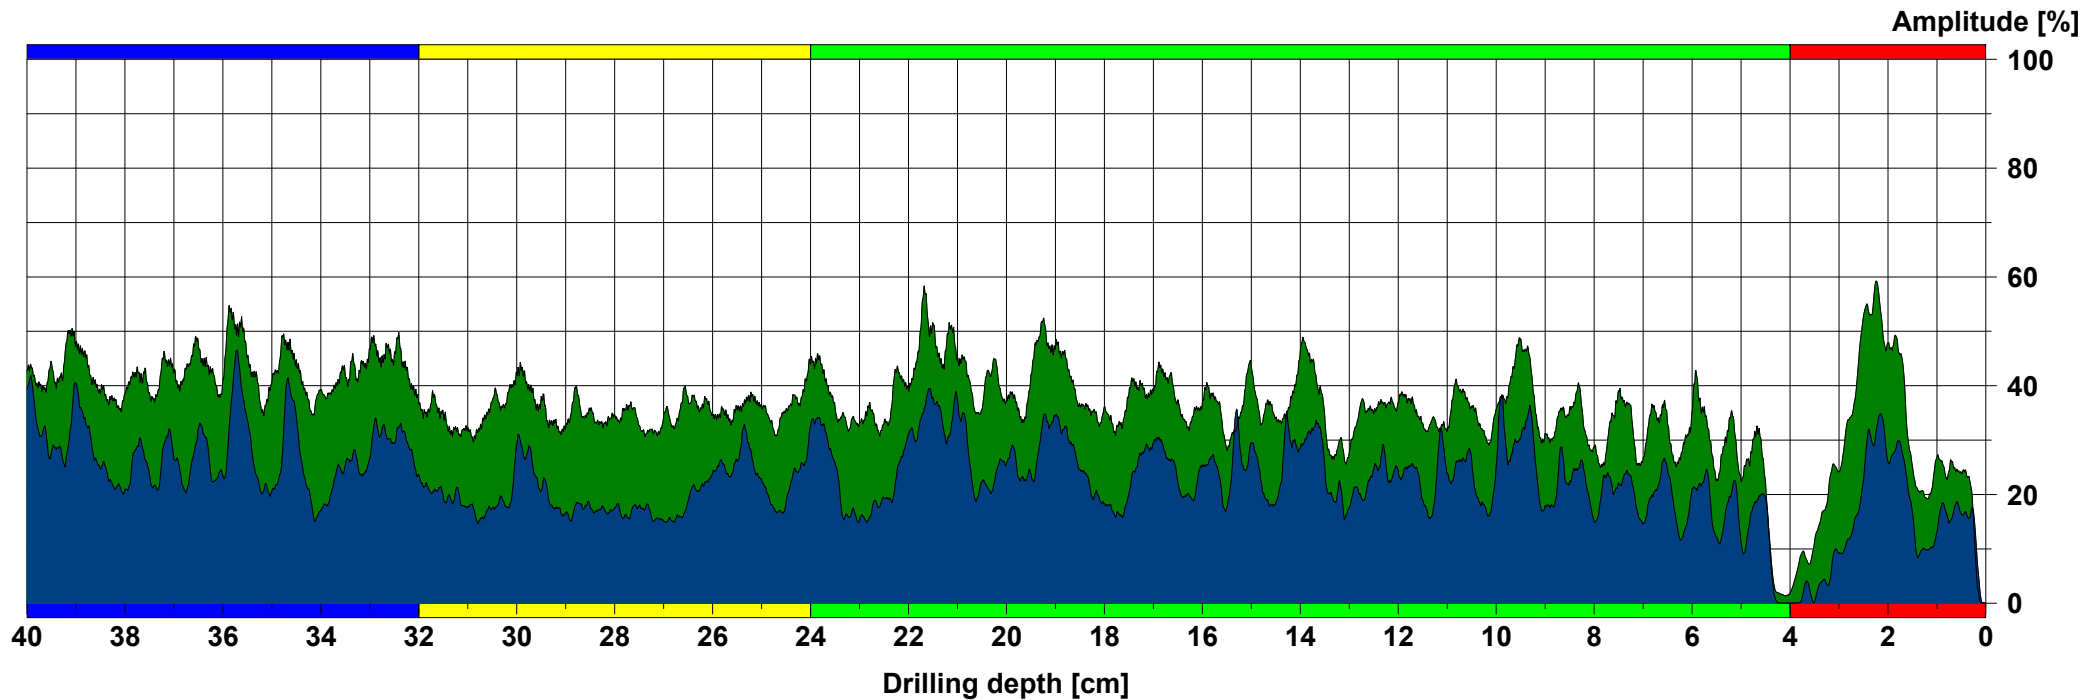
■	From	0,0 cm	to	4,0 cm	:	Bark
■	From	4,0 cm	to	24,0 cm	:	Sound wood
■	From	24,0 cm	to	32,0 cm	:	Slight degradation
■	From	32,0 cm	to	40,0 cm	:	Sound wood
□	From	0,0 cm	to	0,0 cm	:	
□	From	0,0 cm	to	0,0 cm	:

No cause for concern

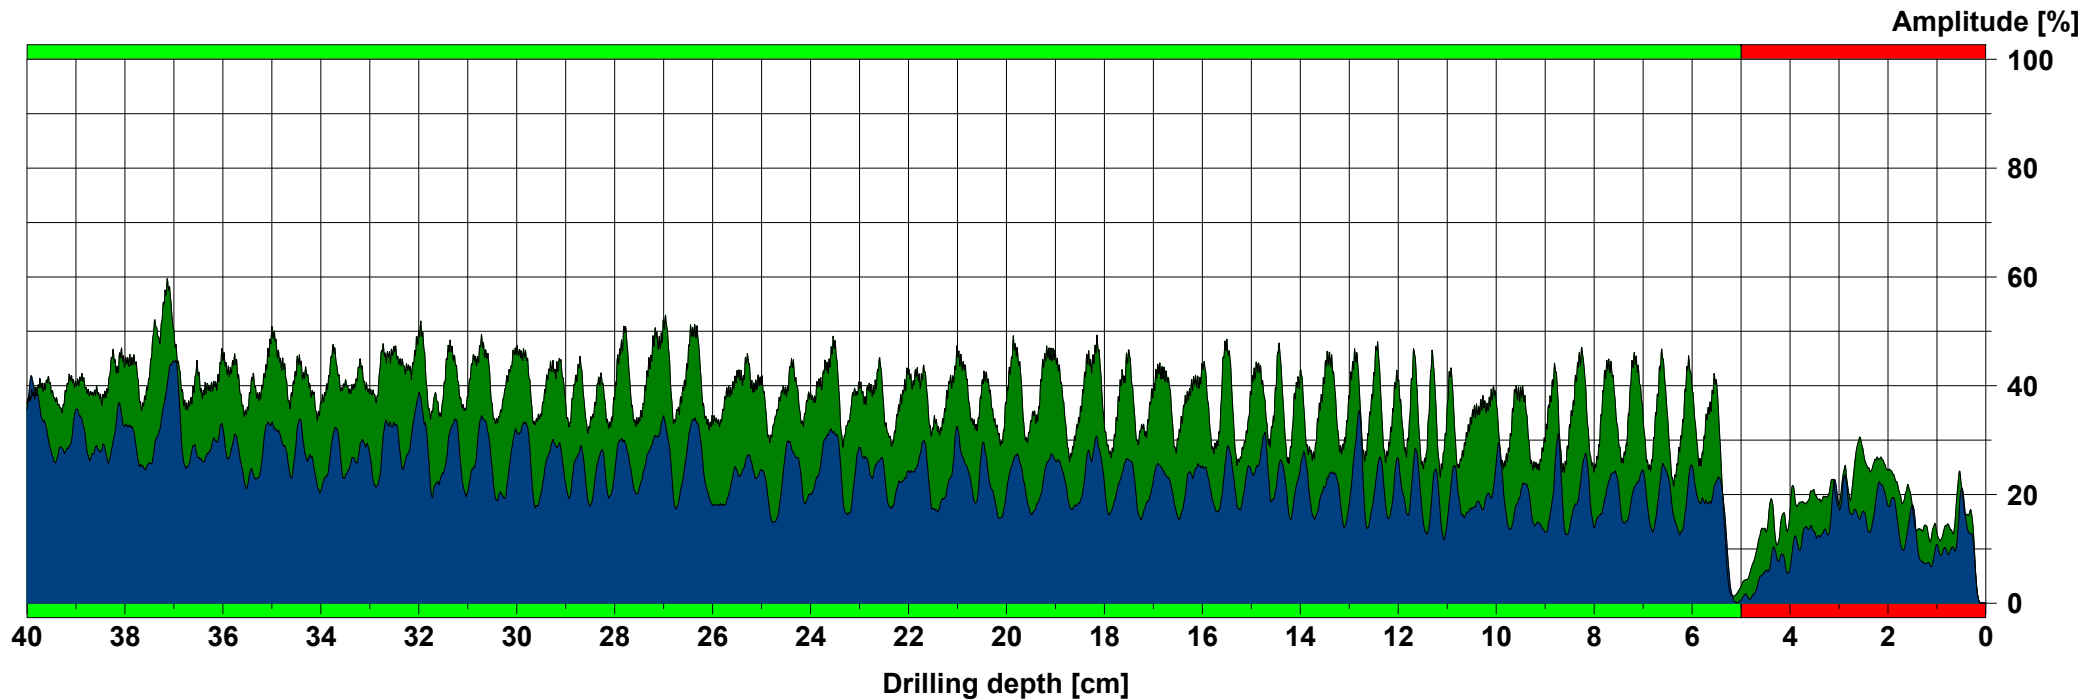
■	From 0,0 cm to 5,0 cm : Bark
■	From 5,0 cm to 40,0 cm : Sound wood
□	From 0,0 cm to 0,0 cm :
□	From 0,0 cm to 0,0 cm :
□	From 0,0 cm to 0,0 cm :
□	From 0,0 cm to 0,0 cm :

No cause for concern

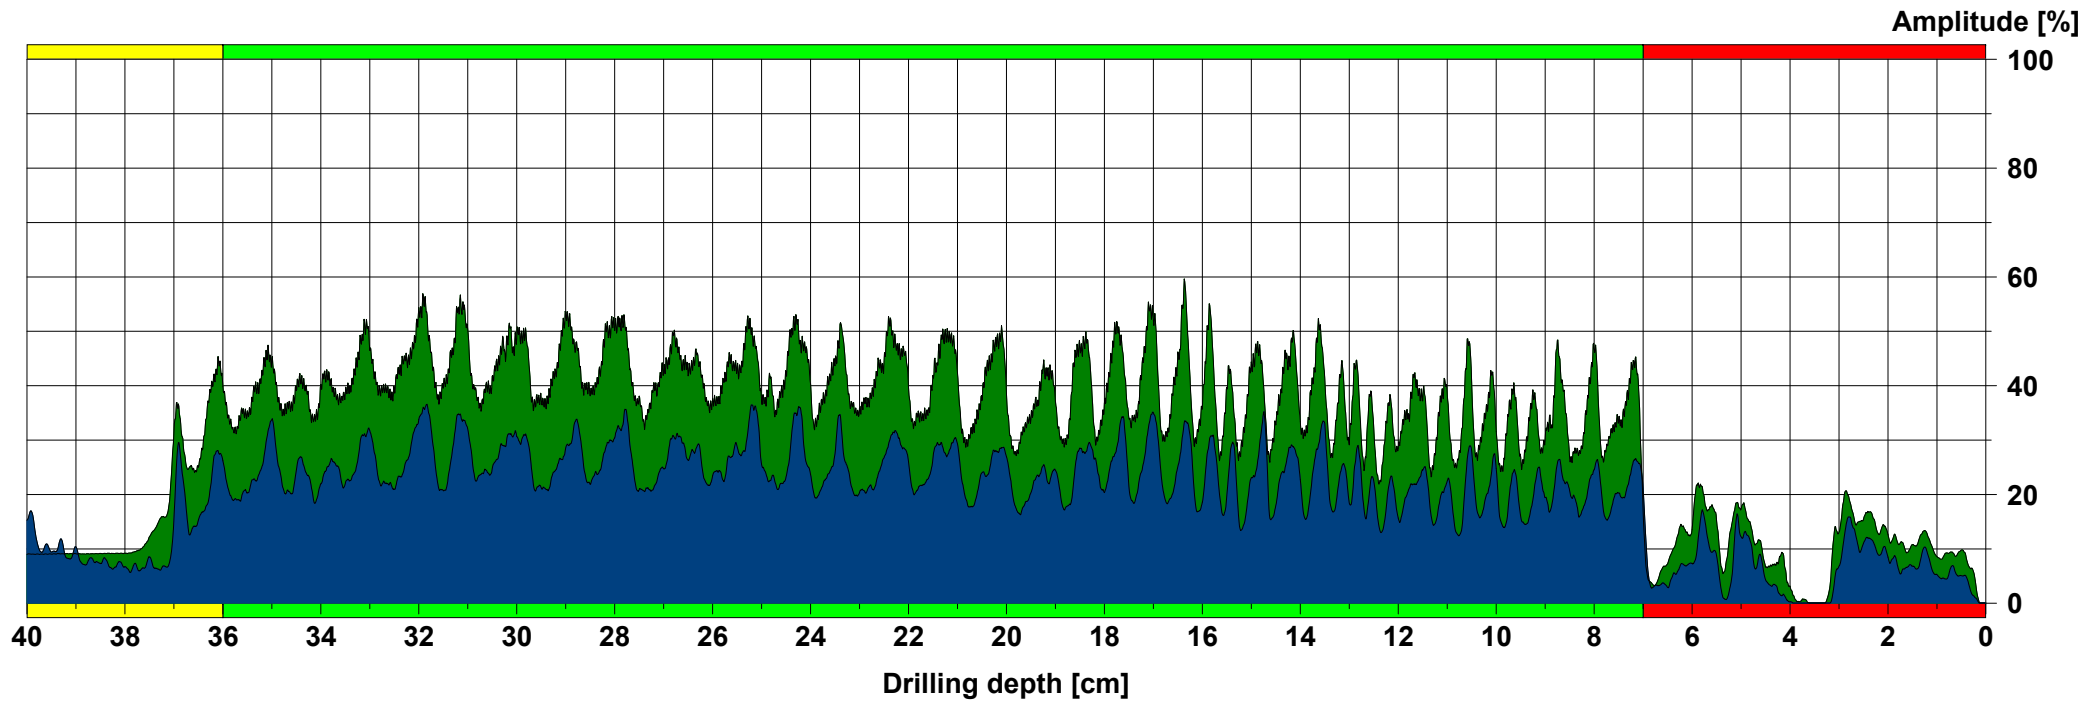
16. At the base of the tree's trunk, approximately 250mm above ground level, I drilled into the trunk from the north, east, south and west. The readings from these tests can be found at **Appendix 1** to this report, numbered 1-4. The results are commented on in the bottom left and right hand corners of each reading. Only the reading taken on the south side showed any sign of decay or dysfunction. However, based on the orientation of the test, it aligns with the shear bomb crack described above.

■	From	0,0 cm	to	7,0 cm	:	Bark
■	From	7,0 cm	to	36,0 cm	:	Sound wood
■	From	36,0 cm	to	40,0 cm	:	Decay or cavity
□	From	0,0 cm	to	0,0 cm	:	
□	From	0,0 cm	to	0,0 cm	:	
□	From	0,0 cm	to	0,0 cm	:

Deep decay or cavity, no cause for concern in isolation but aligns with sheerbomb crack observed on E side fo trunk.

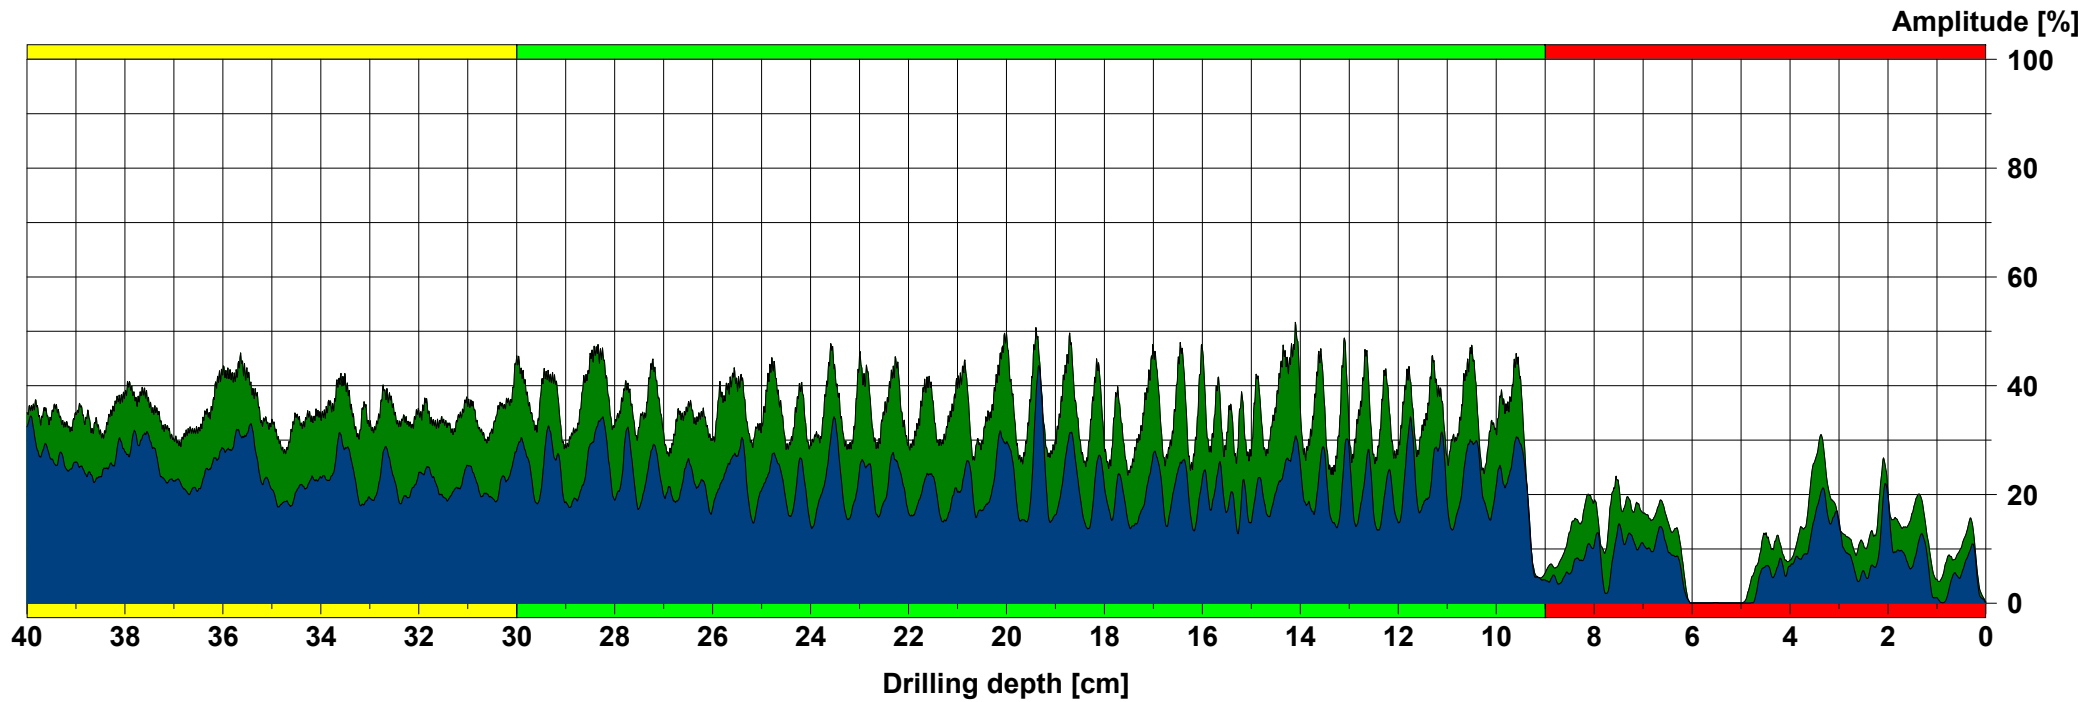
■	From	0,0 cm	to	9,0 cm	:	Bark
■	From	9,0 cm	to	30,0 cm	:	Sound wood
■	From	30,0 cm	to	40,0 cm	:	Slight degradation
■	From	0,0 cm	to	0,0 cm	:	
■	From	0,0 cm	to	0,0 cm	:	
■	From	0,0 cm	to	0,0 cm	:

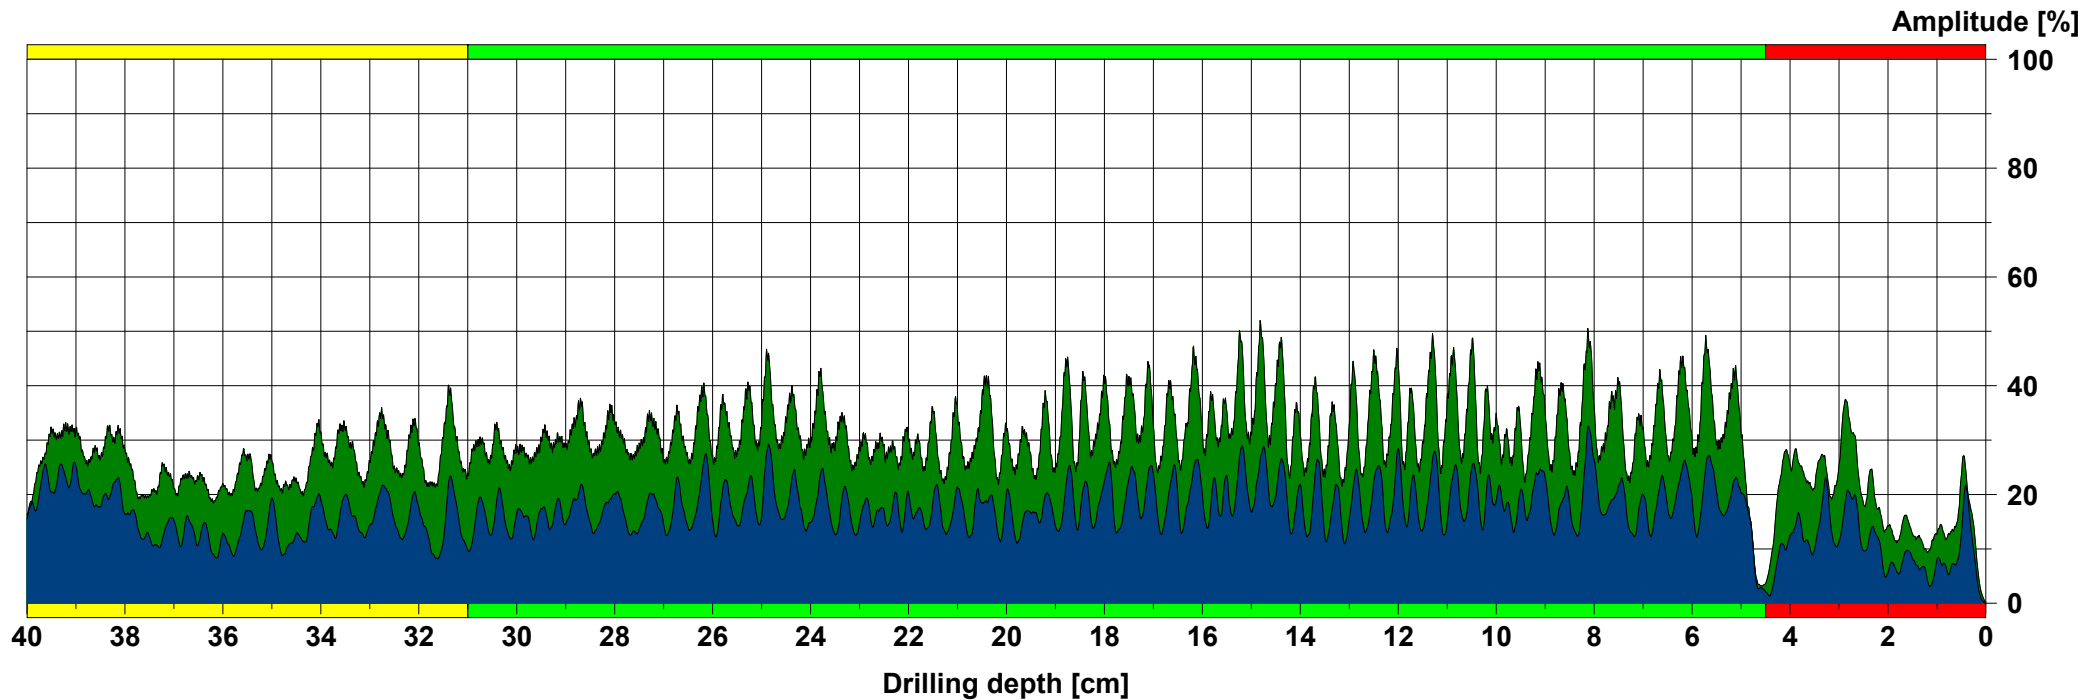
■	From 0,0 cm to 4,5 cm : Bark
■	From 4,5 cm to 31,0 cm : Sound wood
■	From 31,0 cm to 40,0 cm : Slige degradation
■	From 0,0 cm to 0,0 cm :
■	From 0,0 cm to 0,0 cm :
■	From 0,0 cm to 0,0 cm :

No cause for concern in isolation

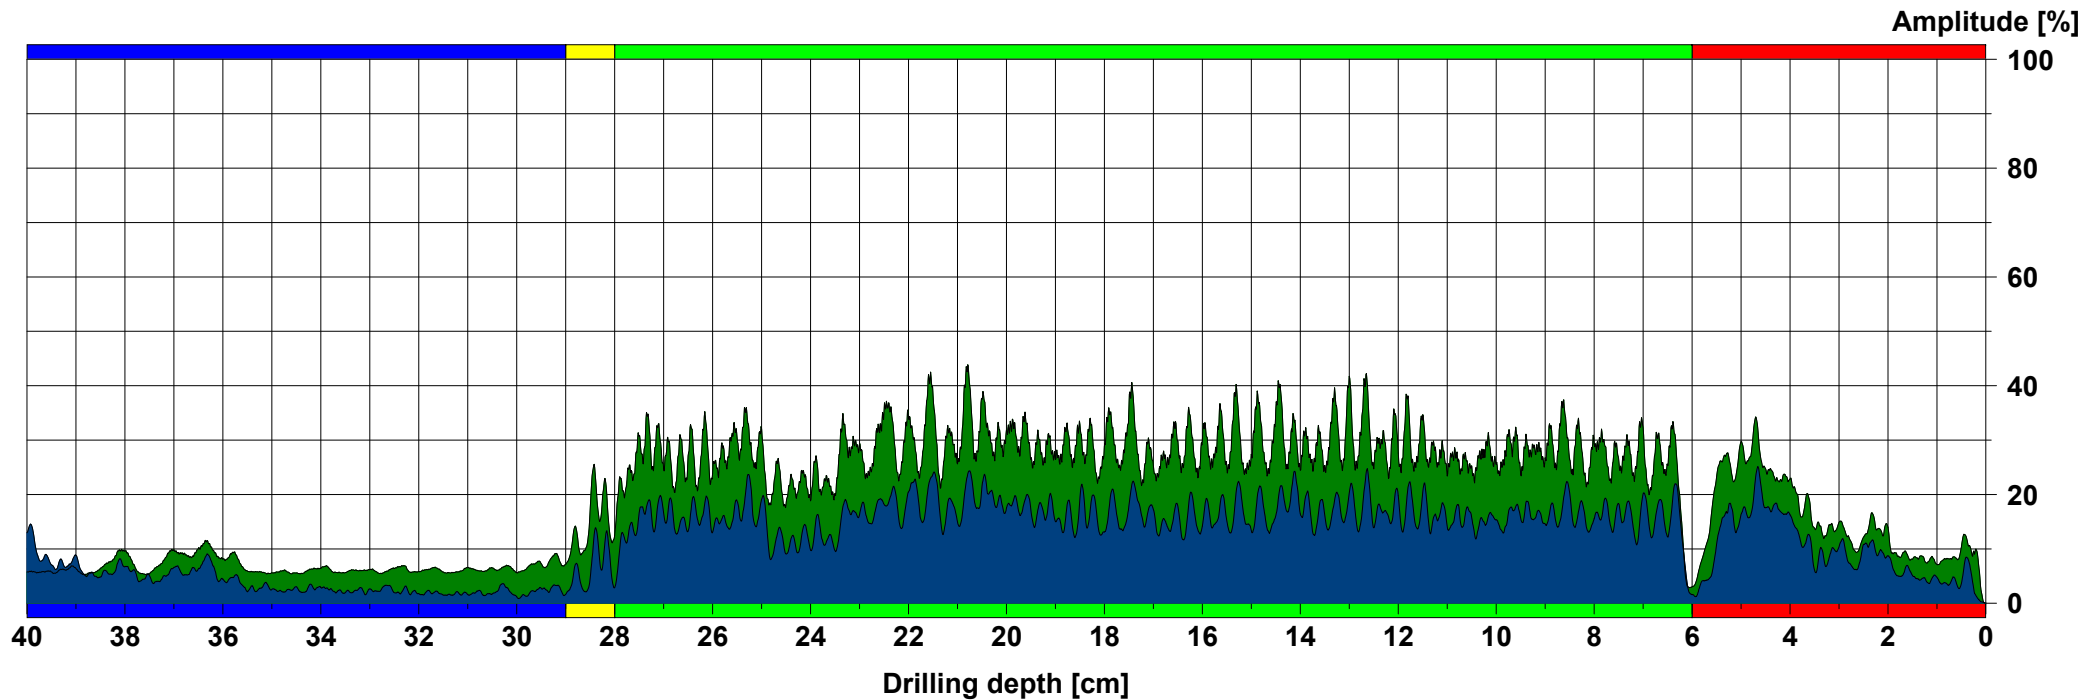
23. In this instance, the west and north-west sides of the tree's trunk at 4m are substantially decayed, with only about 30% residual sound wood. The south and north sides have at least 35cm of sound wood but the wood appears to be weakening at greater depths. On the east side I could not take a reading but this is where the fungal fruiting body was found. Whilst criticisms of Mattheck's work would suggest 30% residual sound wood should be fine, the fact that the location of the decay does not benefit from support by the buttresses; the brown rot does not elicit significant adaptive growth; the sheer size of the tree's canopy coupled with its location and wind exposure; further influenced by the tree's declining physiological condition; all lead me to the conclusion that this decay is significant.

■	From	0,0 cm	to	6,0 cm	:	Bark
■	From	6,0 cm	to	28,0 cm	:	Sound wood
■	From	28,0 cm	to	29,0 cm	:	Transition zone
■	From	29,0 cm	to	40,0 cm	:	Decay
■	From	0,0 cm	to	0,0 cm	:	
■	From	0,0 cm	to	0,0 cm	:

Trunk radius is 83.5cm (not including bark).
 sound wood is 22cm thick meaning decay is
 61.5cm deep.

26. In light of the above discussion I conclude that the best course of action is to fell the tree now rather than wait to clear up what destruction arises as the consequence of failure. I do not think there is a suitable alternative that can be achieved through pruning the tree instead, although it might be appropriate to retain a standing hulk of deadwood habitat.

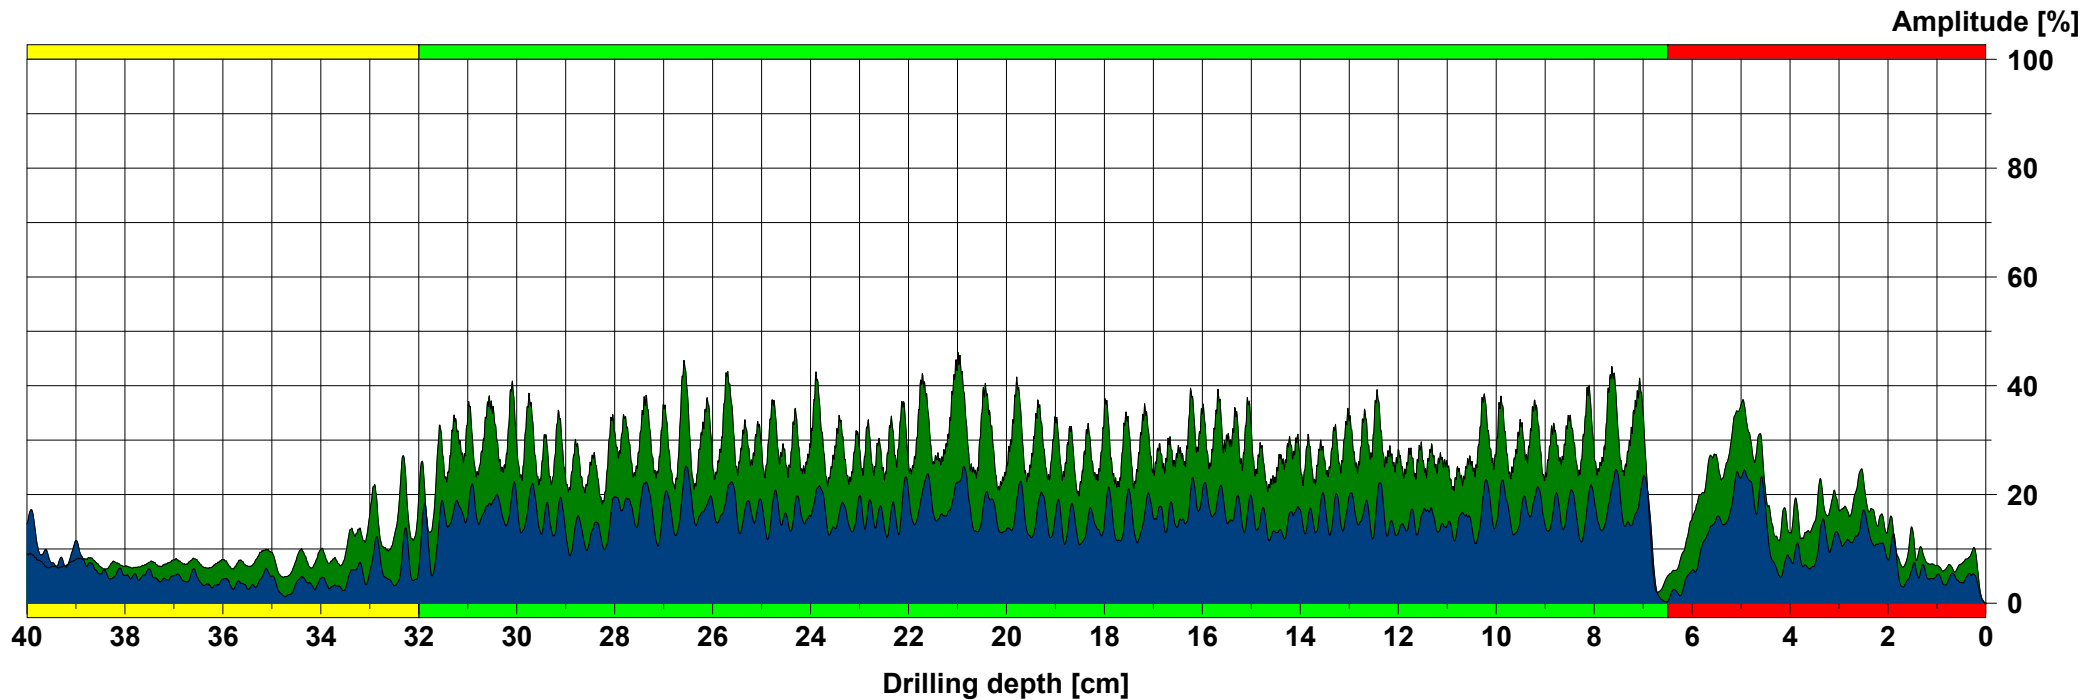
■	From	0,0 cm	to	6,5 cm	:	Bark
■	From	6,5 cm	to	32,0 cm	:	Sound wood
■	From	32,0 cm	to	40,0 cm	:	Decay
■	From	0,0 cm	to	0,0 cm	:	
■	From	0,0 cm	to	0,0 cm	:	
■	From	0,0 cm	to	0,0 cm	:

Trunk radius of 83cm (not including bark. Sound wood is 25.5cm thick and decay is 57.5cm deep.

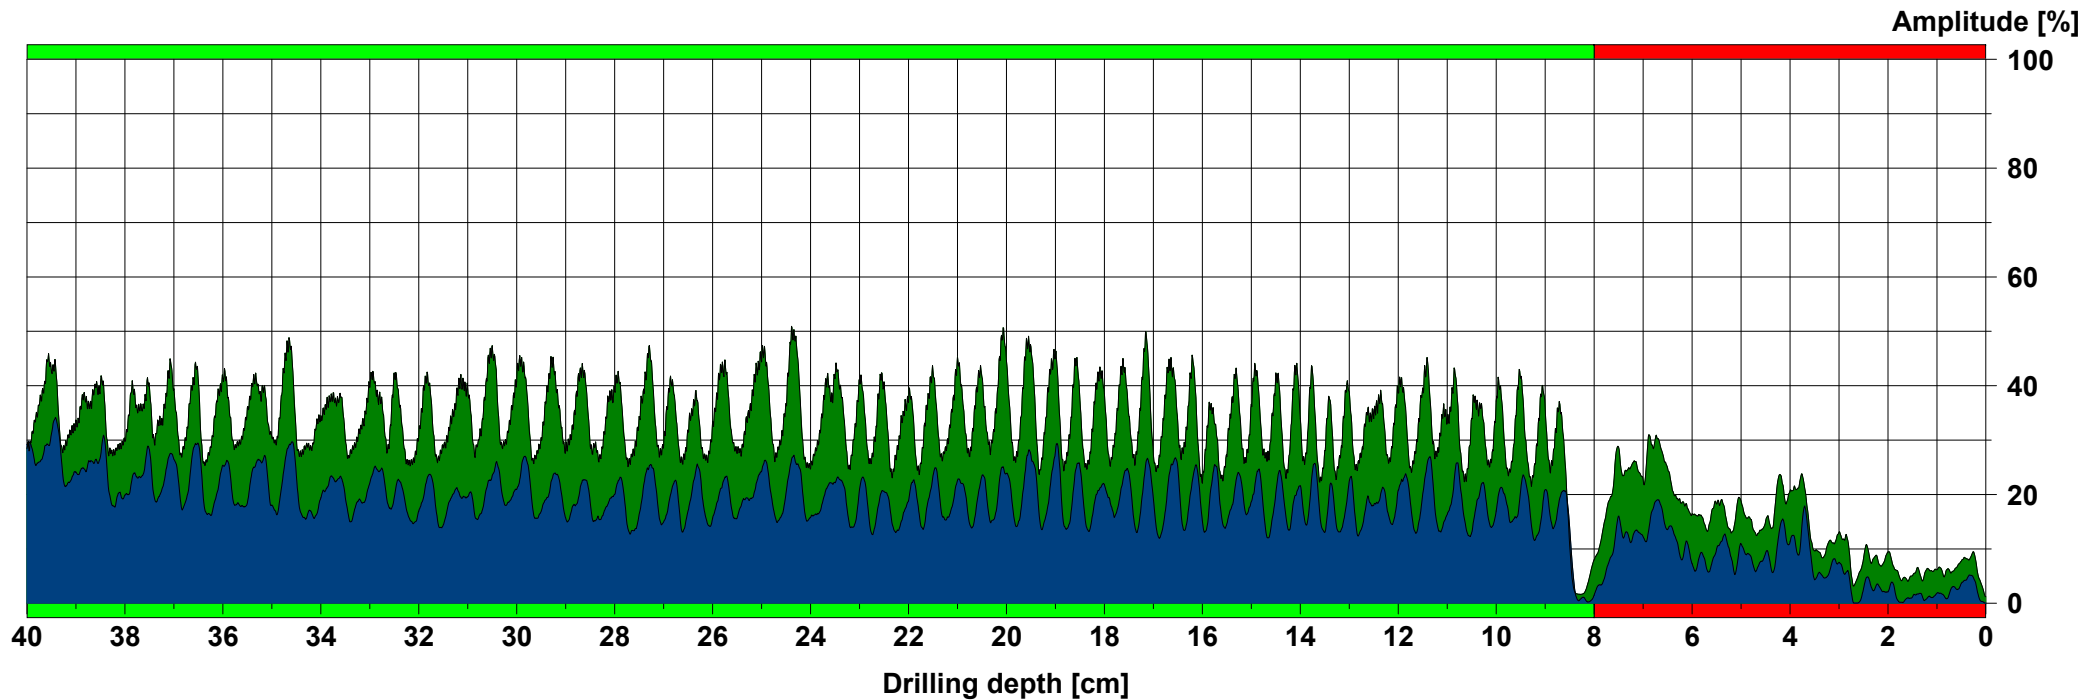
■	From 0,0 cm to 8,0 cm : Bark
■	From 8,0 cm to 40,0 cm : Sound wood
	From 0,0 cm to 0,0 cm :
	From 0,0 cm to 0,0 cm :
	From 0,0 cm to 0,0 cm :
	From 0,0 cm to 0,0 cm :

No cause for concern in isolation, soundness of wood seems to be reducing at greater depth.
