Weston Shore Infant School

Roof Condition Survey

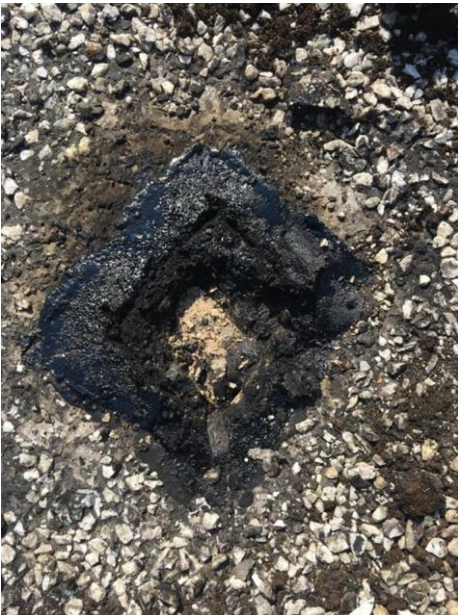
Core Analysis sample showed the deck to be dry.

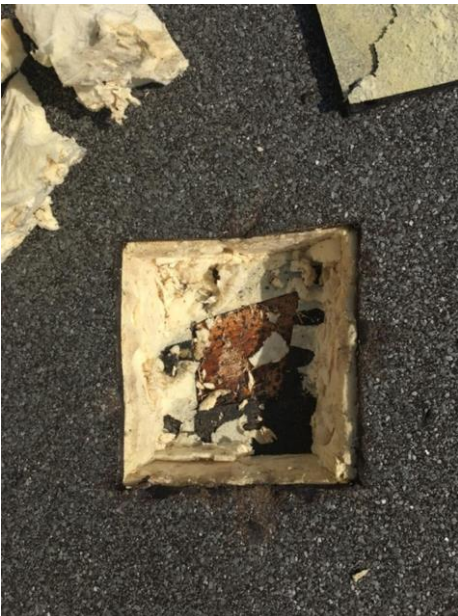
The core analysis was dry in the area that was cored.

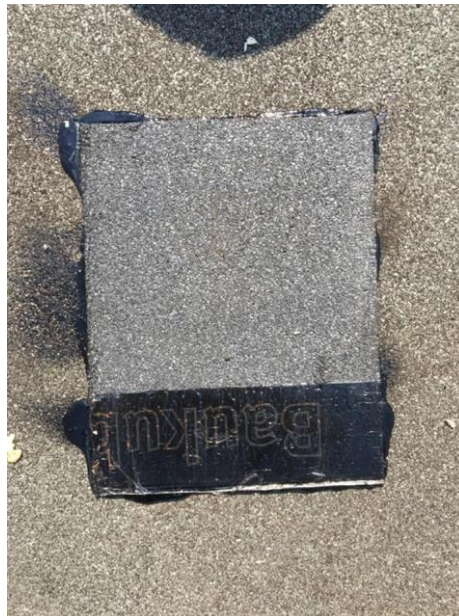
Both core samples were left in a water tight condition.

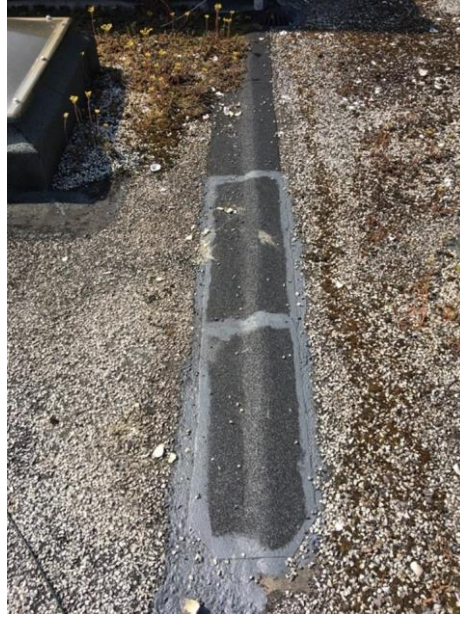
Many areas of this roof have been repaired using either Aquapol or a commodity membrane.

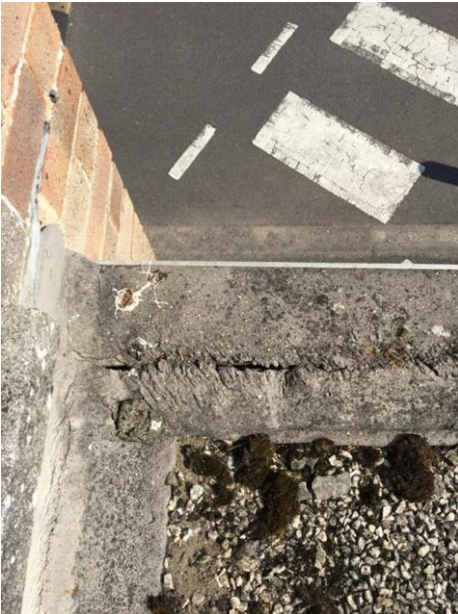
There are splits and cracks in the asphalt. This school was built in 1974 and this is probably the original roof.

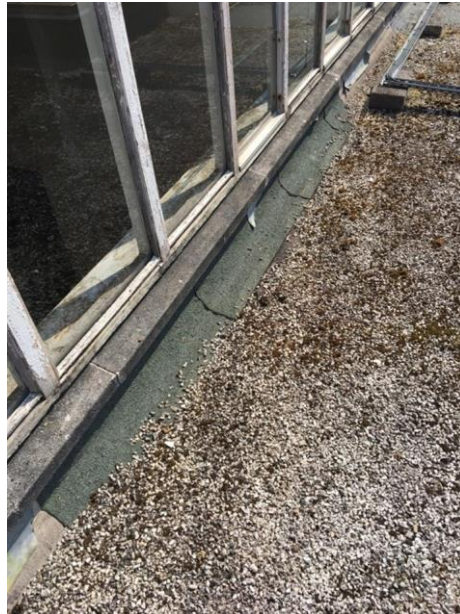
The area under the windows shows where the cover flashing is missing and a repair using felt has been carried out.

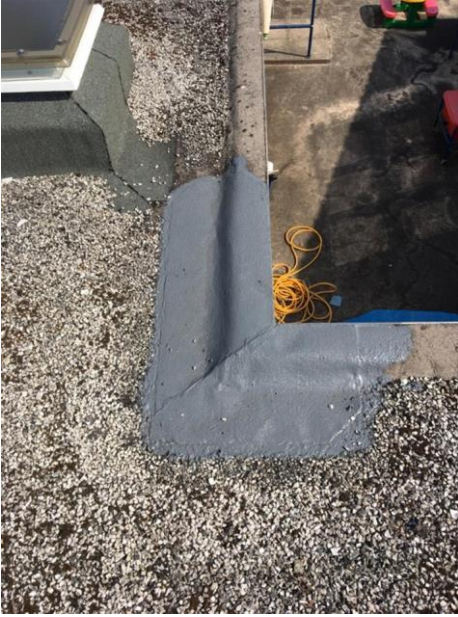
This picture shows where the detailing is failing and water ingress has occurred.

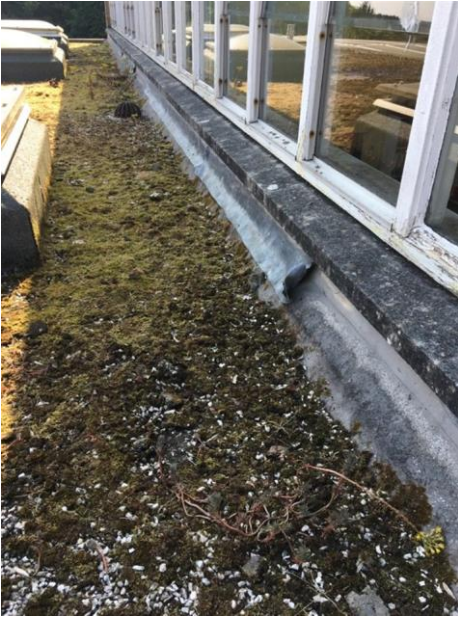
The amount of vegetation on the roof suggests that ponding water is a real issue.

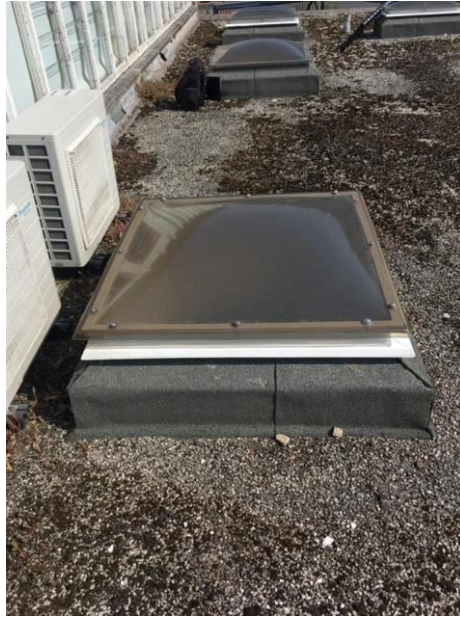
All the roof lights will be changed in the event of a complete refurbishment. The new lights will be triple skinned poly carbonate.

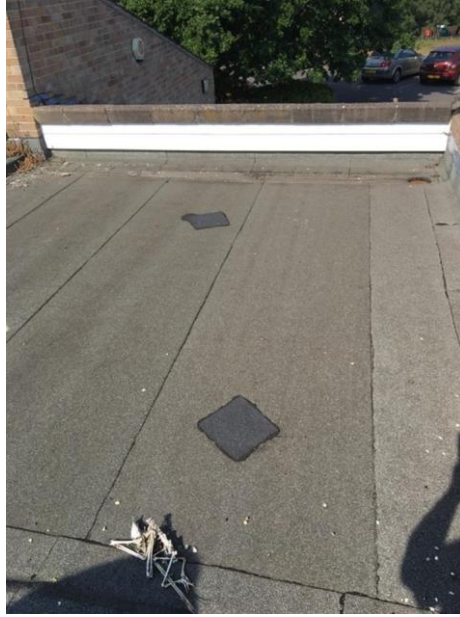
The bituminous roof sections are in good condition.

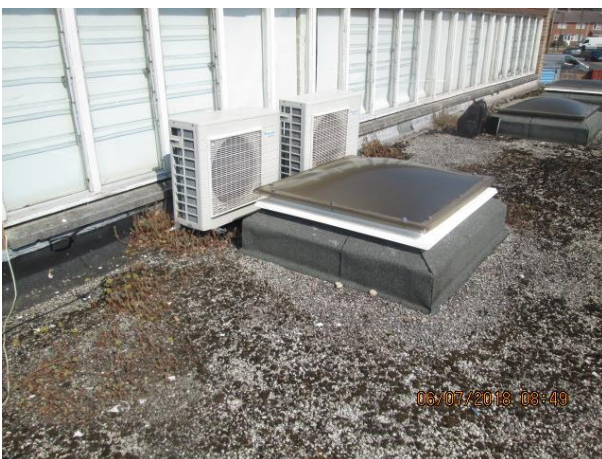
Main roof – Rooflight and Air conditioning condenser on asphalt roof adjacent to pitched roof 3

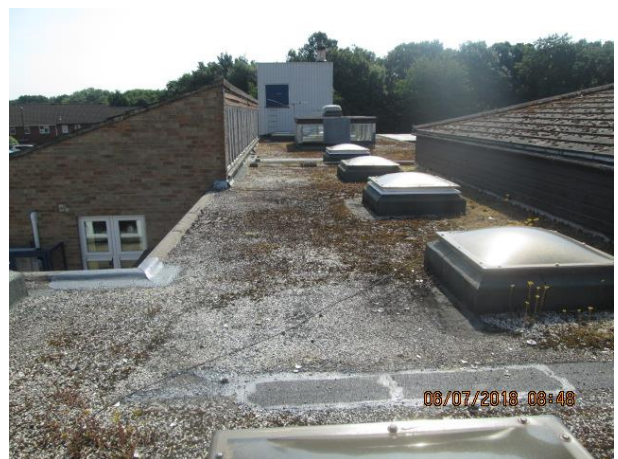
Main roof looking towards tank room, pitch roof 1 on left, hall roof on right

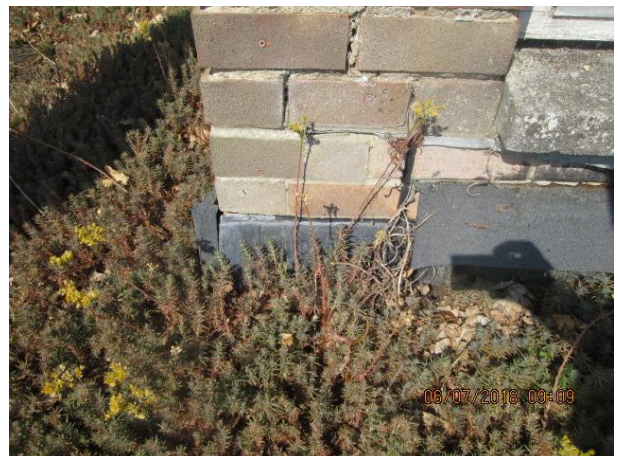
Plant growth and cracking to brickwork, pitched roof 2

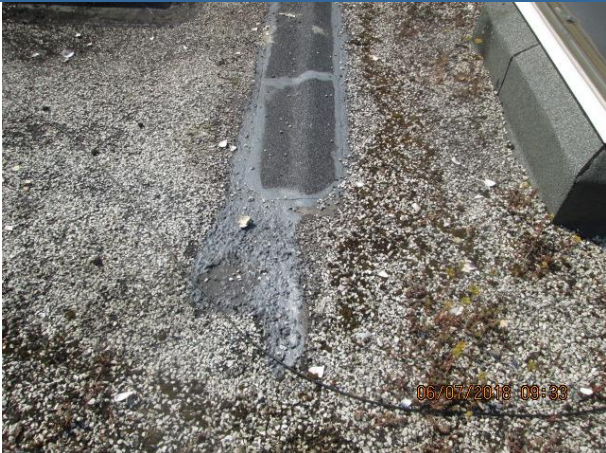
Main roof - patch repair

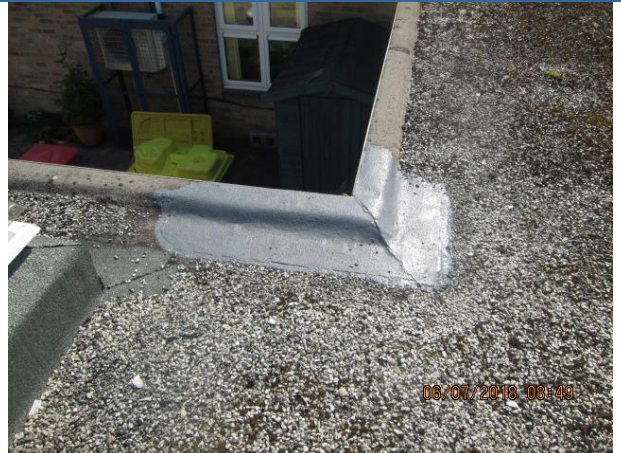
Main roof – edge patch repair

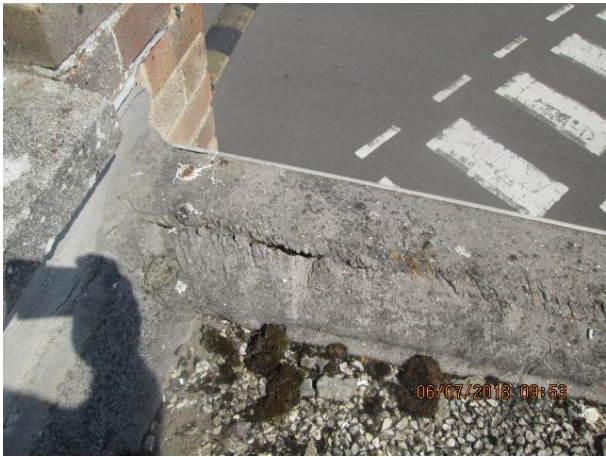
Split asphalt edge detail

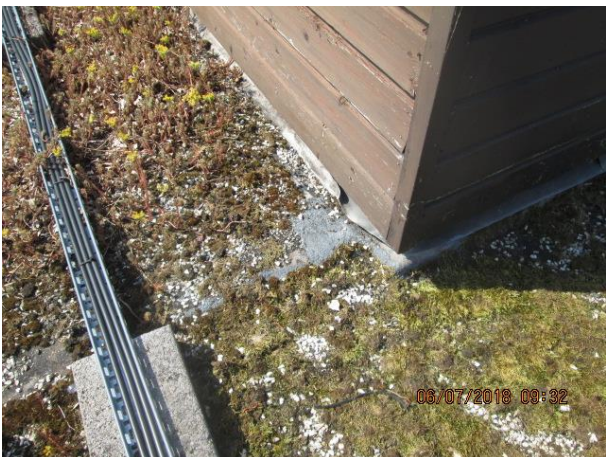
Main roof – poor detailing, level change and damaged flashing

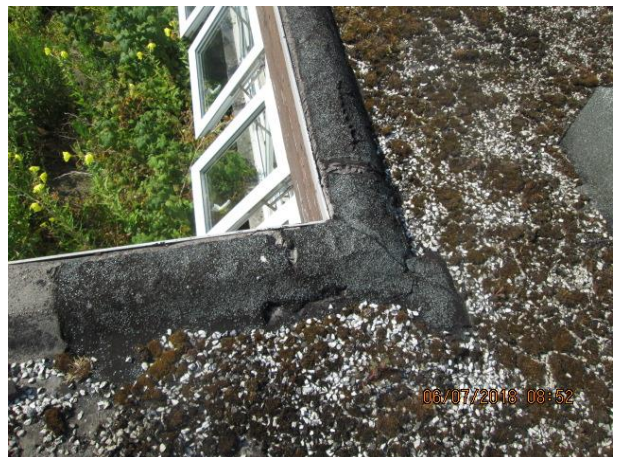
Edge detail patch repair

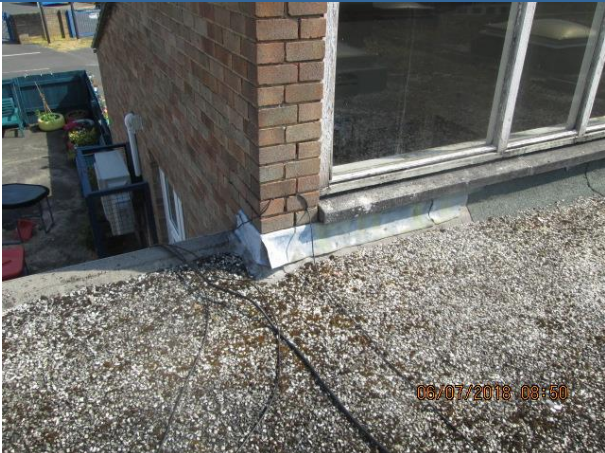
Main roof flashings and high level windows

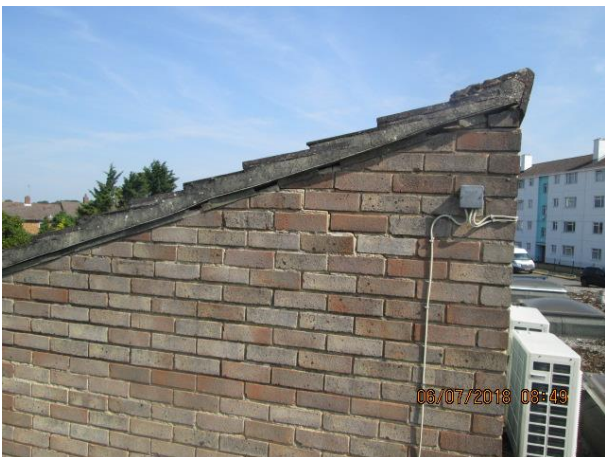
Example of non-roofing fabric requiring repairs

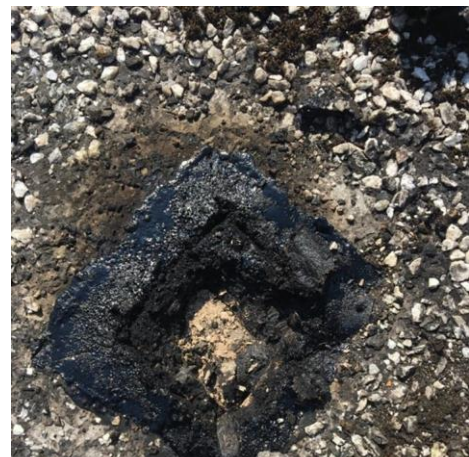
Core sample of Asphalt roof

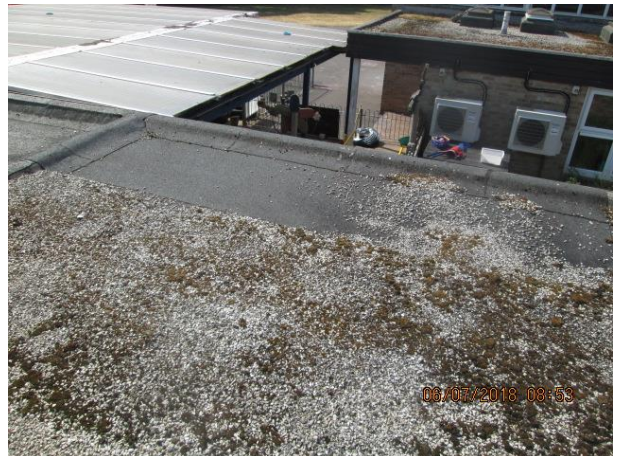
Patch repair to main asphalt roof adjacent small roof 3

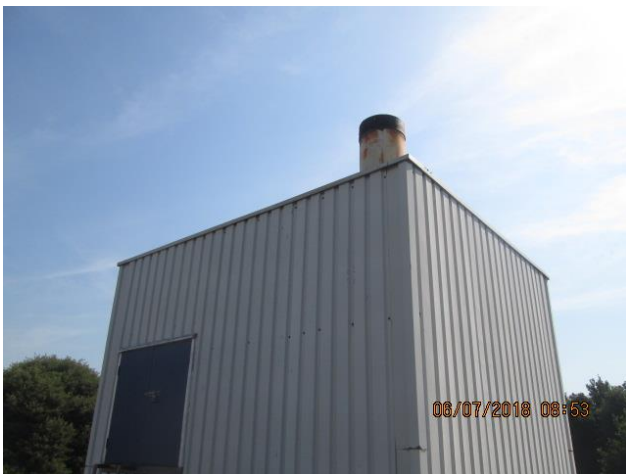
Tank room roof edge detail similar to main roof

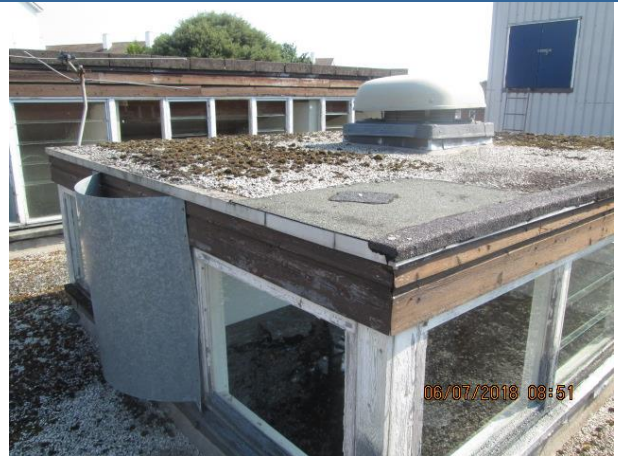
Raised kitchen roof – asphalt with patch repairs

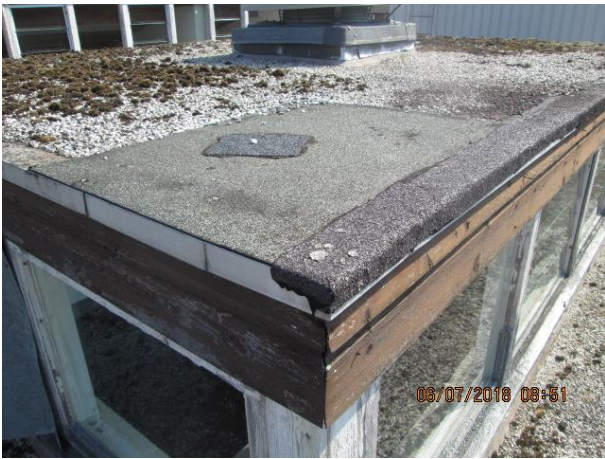
Kitchen roof – patch repair

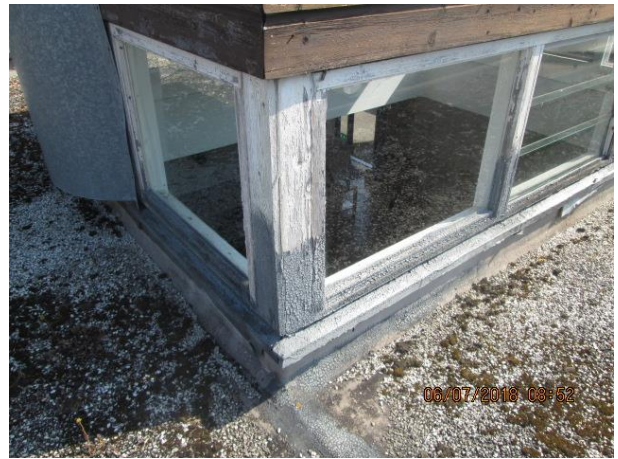
Clerestory kitchen windows

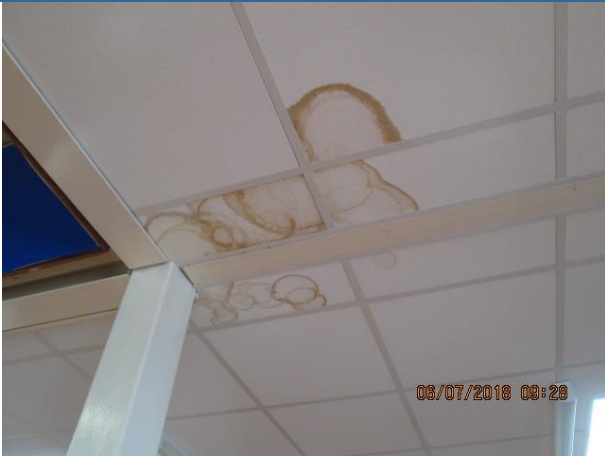
Water staining to corner of hall roof

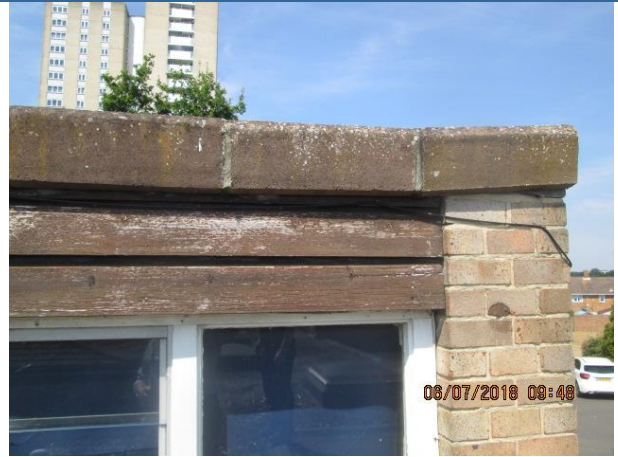
Area of building requiring maintenance

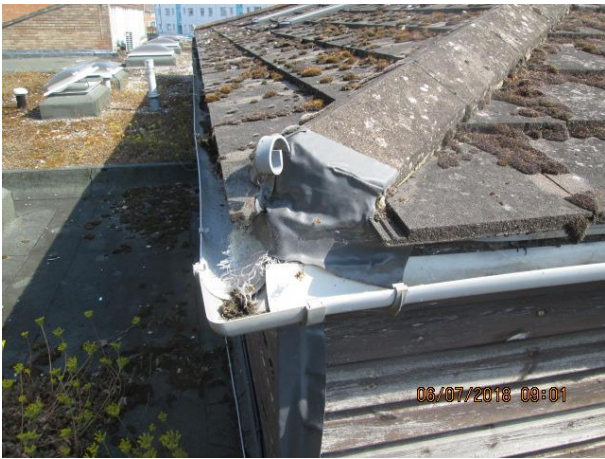
Patch repair to hall roof hip tiles

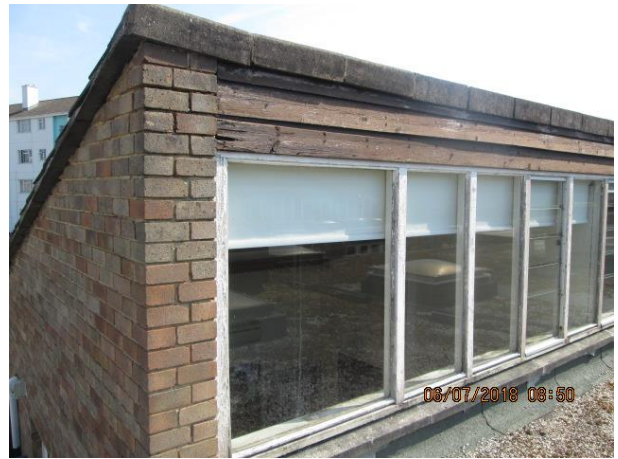
Area of building requiring maintenance and single glazing

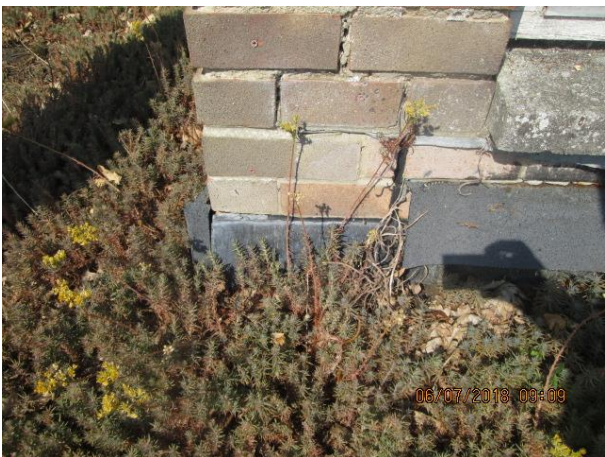
Brickwork cracking and excessive plant growth on roof

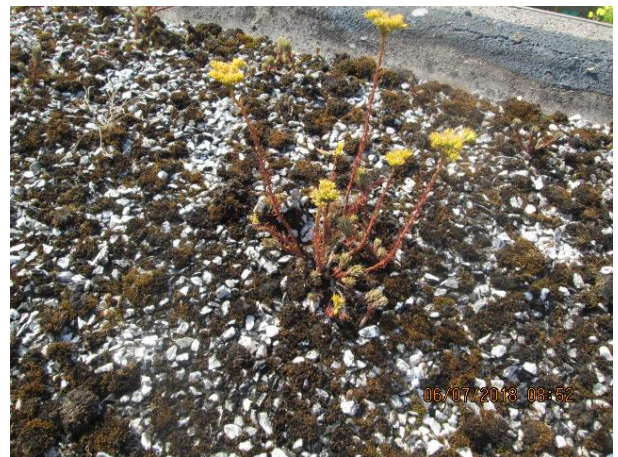
Plant growing in stones and debris on roof

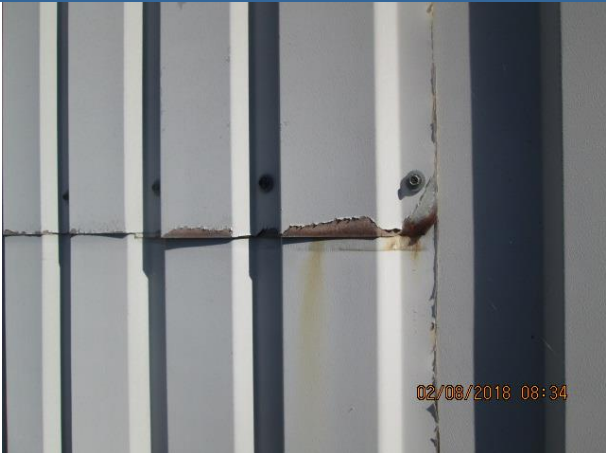
Corroding Tank room cladding at sheet ends

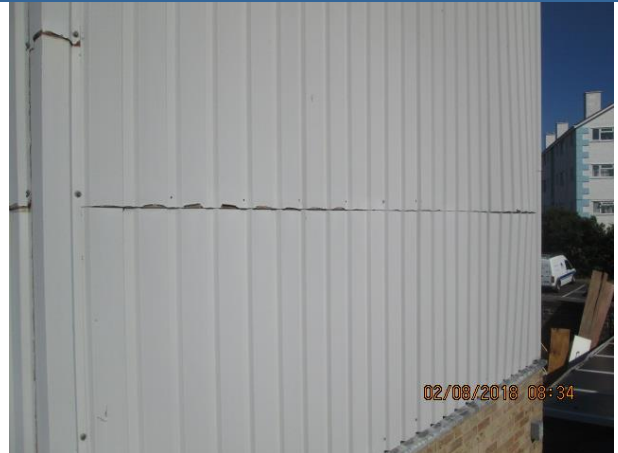
Bulge in cladding - East elevation

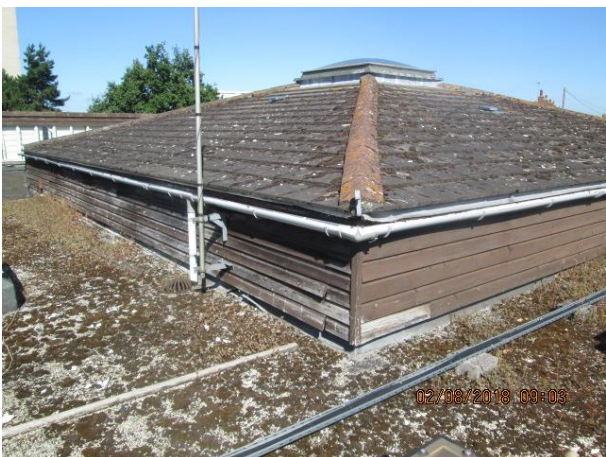
Hall roof. Decaying cladding and poor guttering

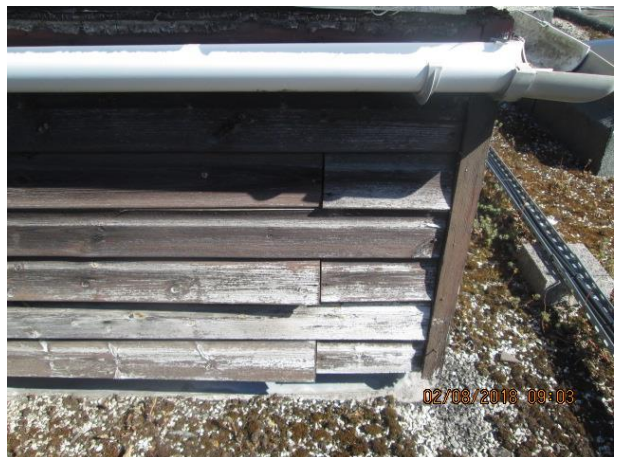
Warped and cracked cladding

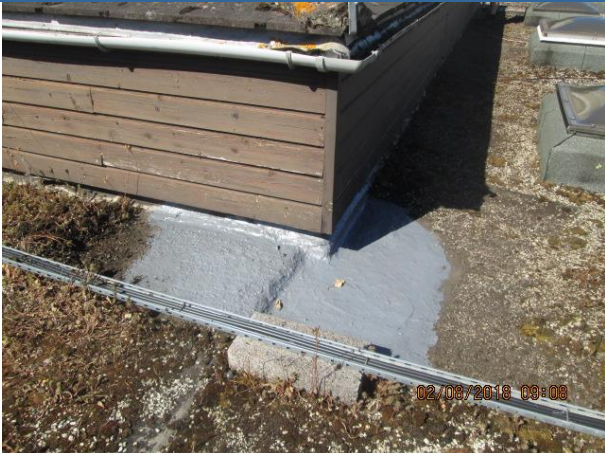
Recent Acrypol repair to asphalt roof adjacent to hall roof North East corner

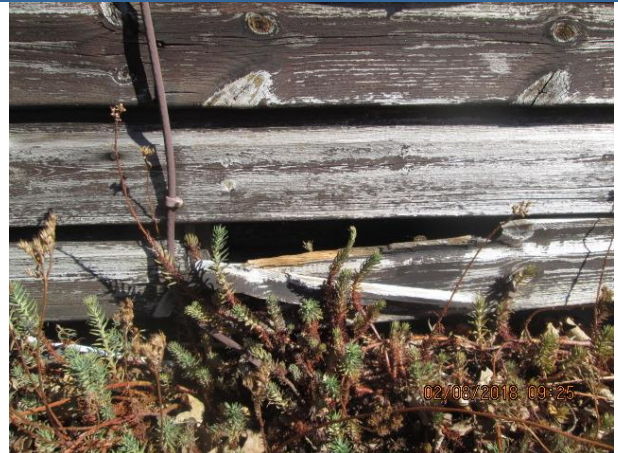
Broken hall roof cladding and plant growth below

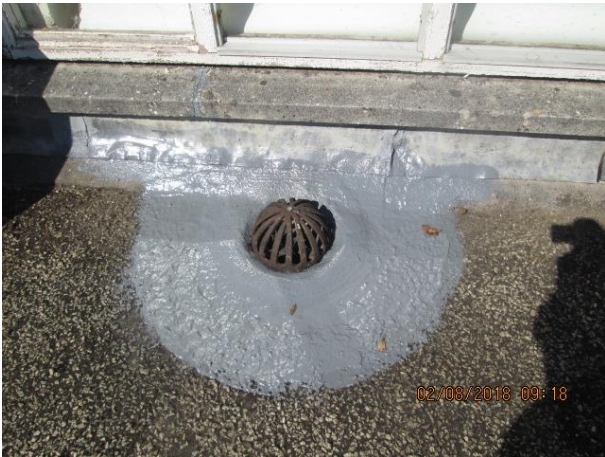
Recent Acrypol patch repair to asphalt roof adjacent to pitched roof 3

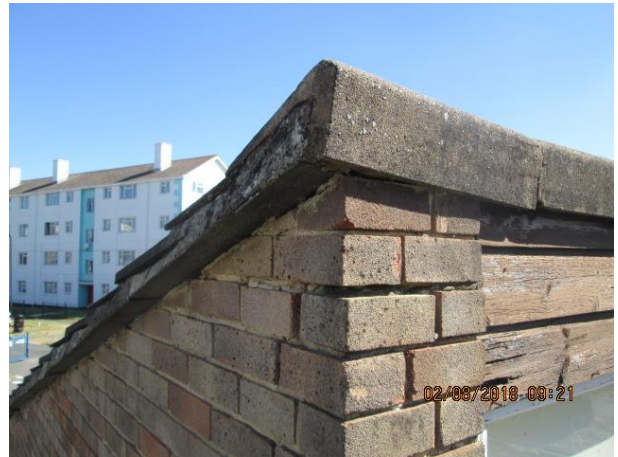
Pitched roof 1, lifting and opening mortar joints

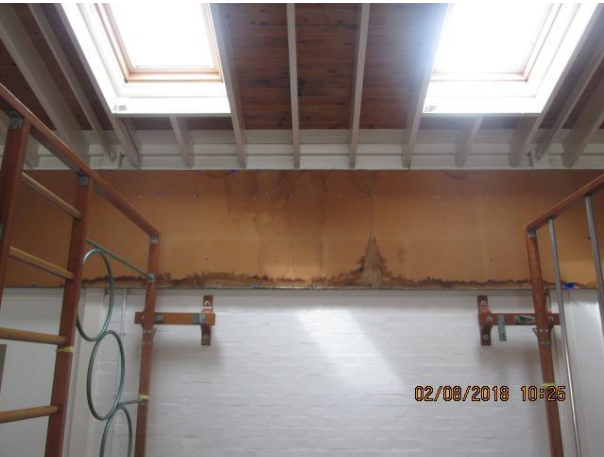
Water staining in hall

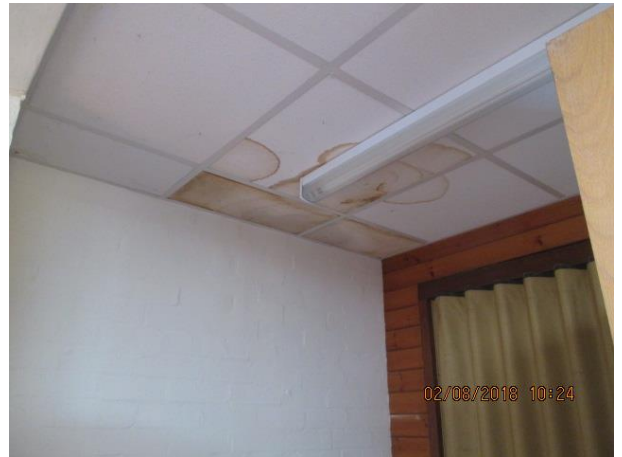
Stained ceiling below pitched roof 1

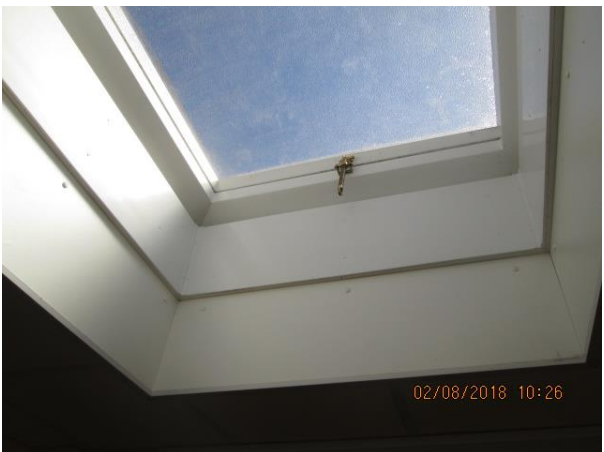
Internal of rooflight

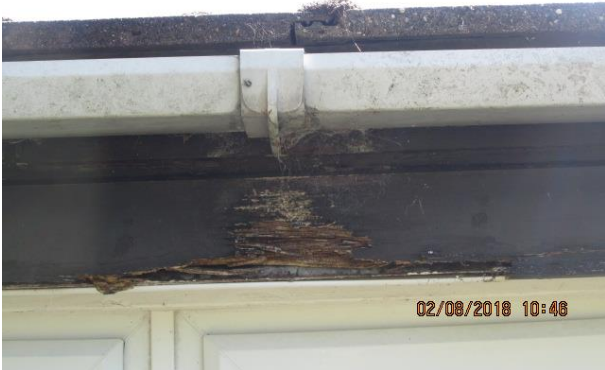
Leaking gutter water damage to fascia

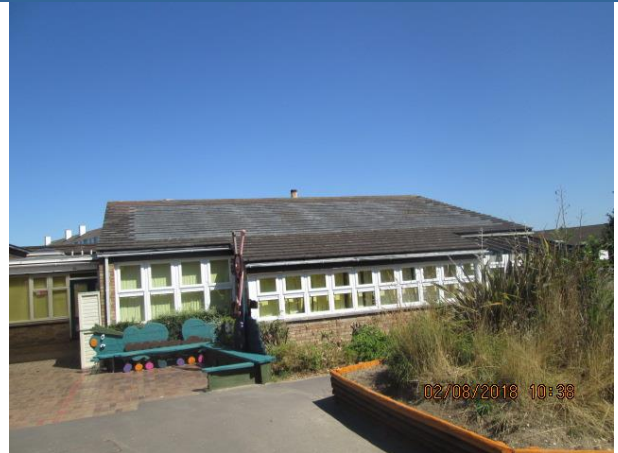
Pitched roof 5 – Solar panel tiles

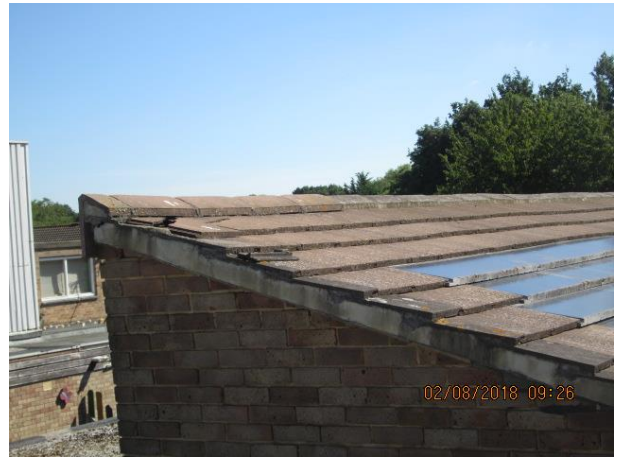
Pitched roof 5 – broken tiles

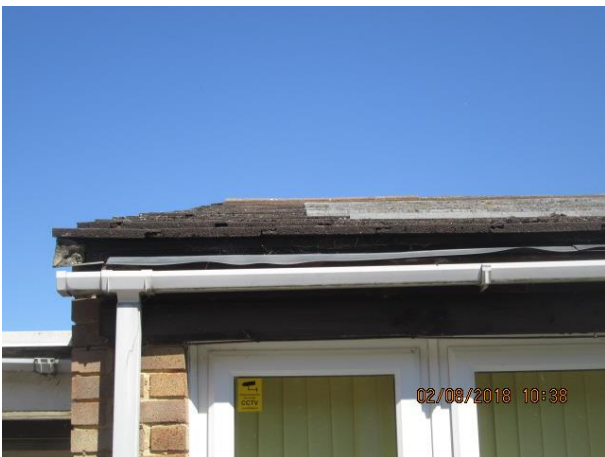
Pitched roof 5 – raised tiles but gutter at original lower level

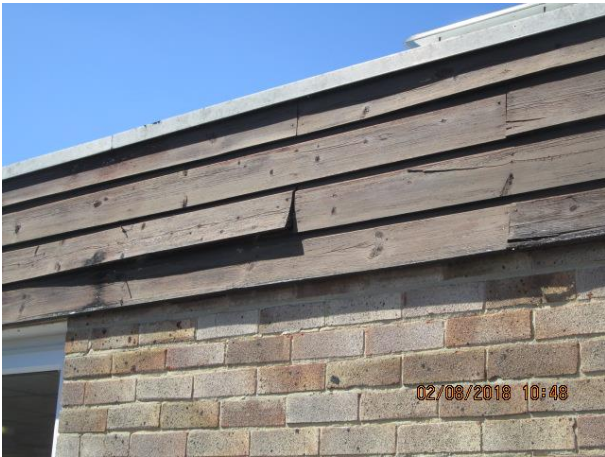
Example of warped and cracking fascia with minimal decoration

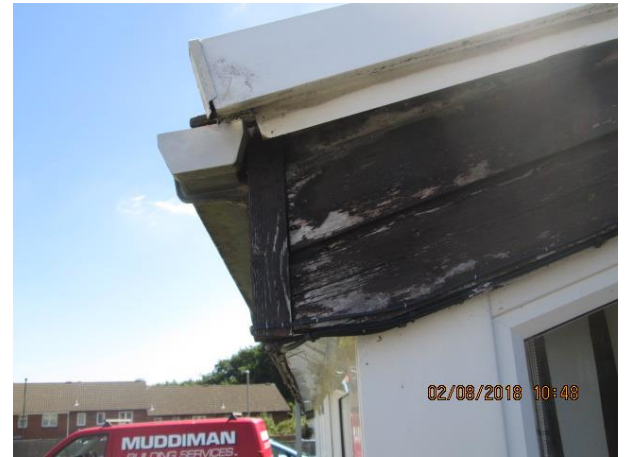
Degraded timber barge board

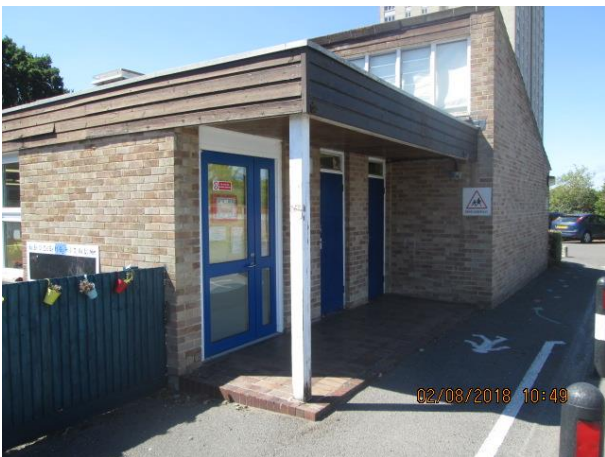
Corner post under asphalt roof

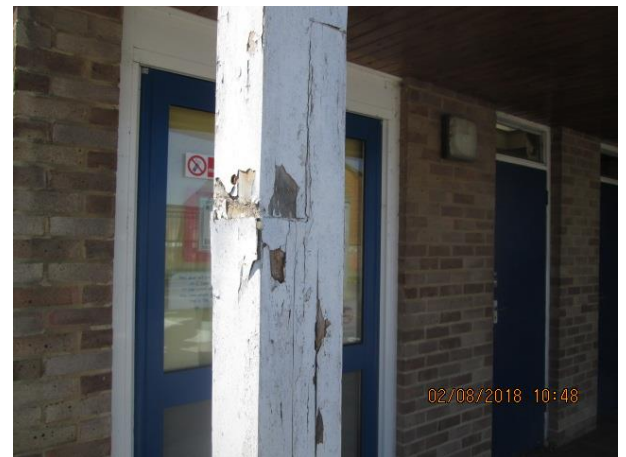
Previous repair to post now failing

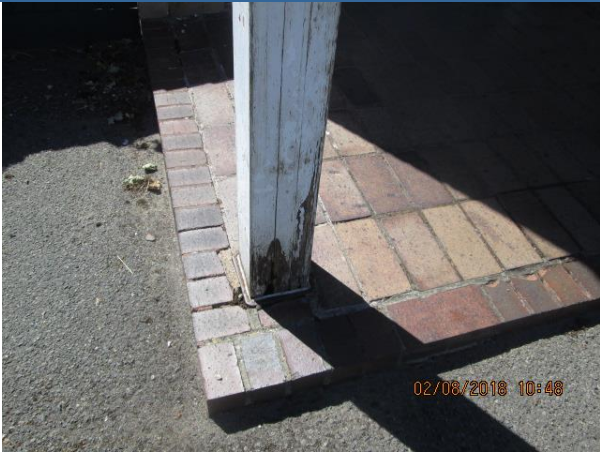
Repaired and eroding post

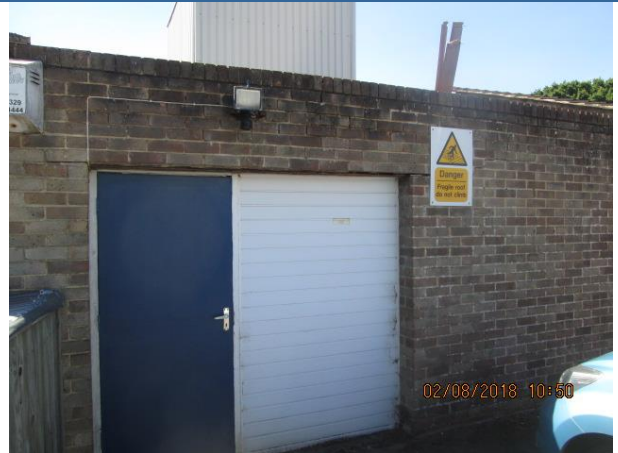
Lintol rusting and lifting brickwork over store door

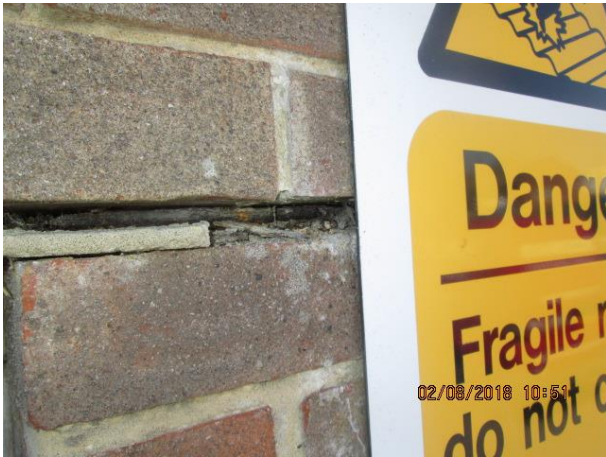
Rusting lintol lifting brickwork

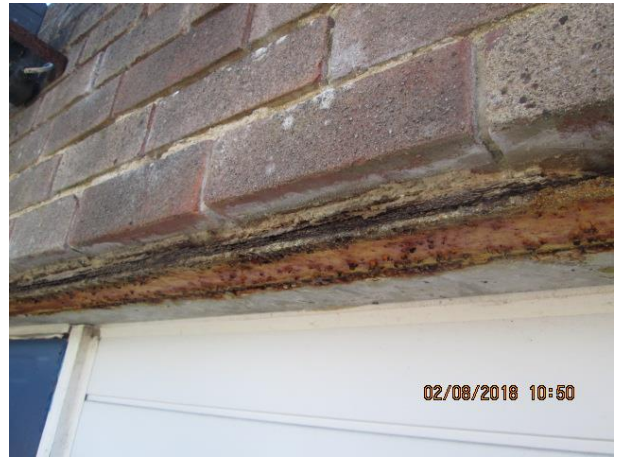
Rusting lintol over store door

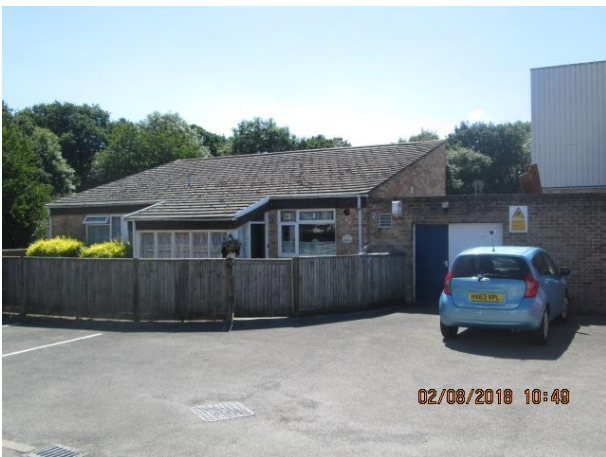
Caretaker's bungalow – North elevation
