## Appendix A – Data Received

## Appendix A1 Southampton SWMP: Data Collection Status

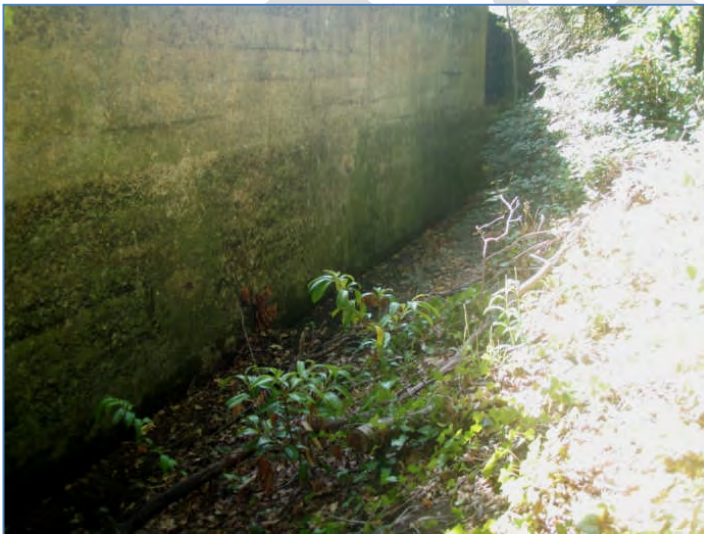
**Figure 2. Ephemeraally flowing upstream section of Rolles Brook along side very high wall protecting properties behind.**

Leave this section as it is and keep maintenance to a minimum to provide for a range of habitat features. Only remove large woody vegetation if it is creating a major unacceptable blockage or, could over the longer term, affect the integrity of the wall on the left hand bank.

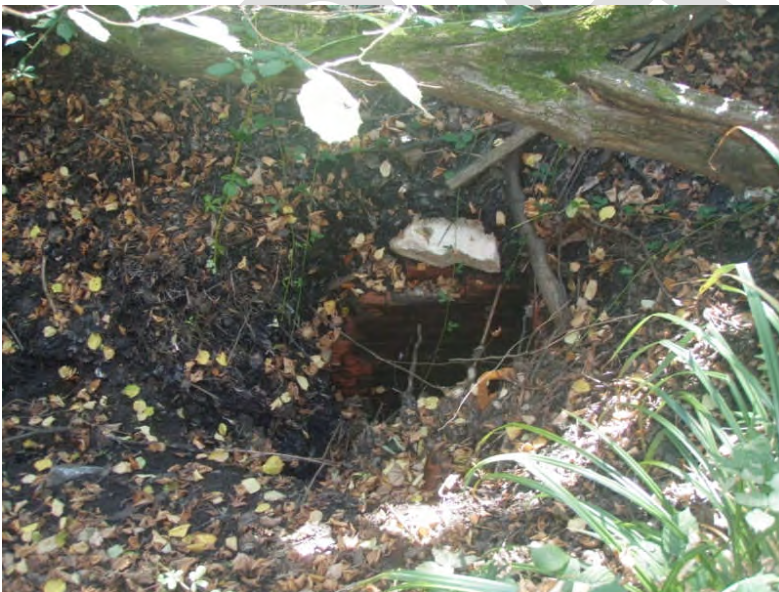
**Figure 3. Small culvert entrance now blocked and in bad state of repair (culvert requirement no longer obvious).**

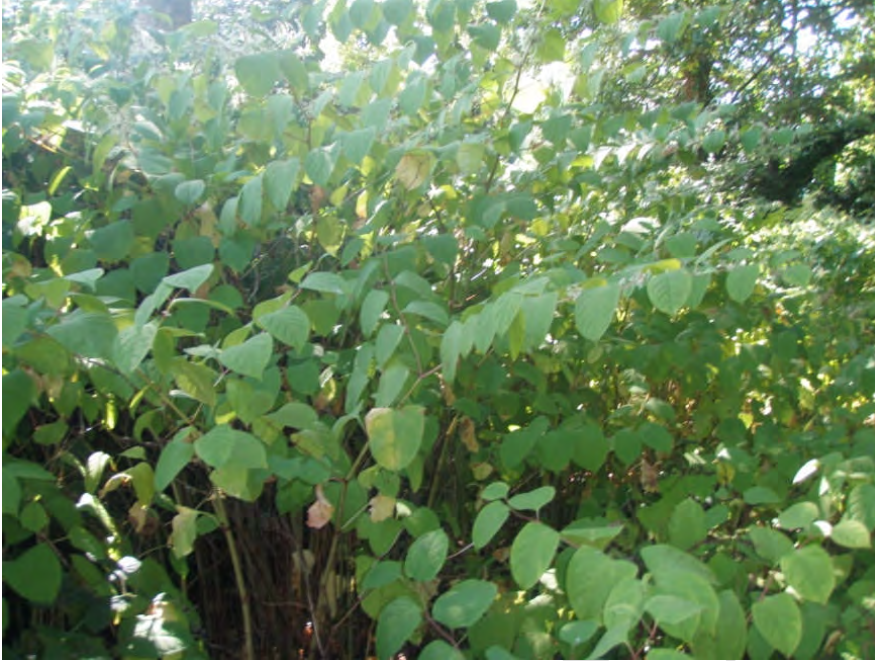
**Figure 4. Large stand of Japanese Knotweed near culvert entrance**

An eradication programme for the Japanese Knotweed is recommended.

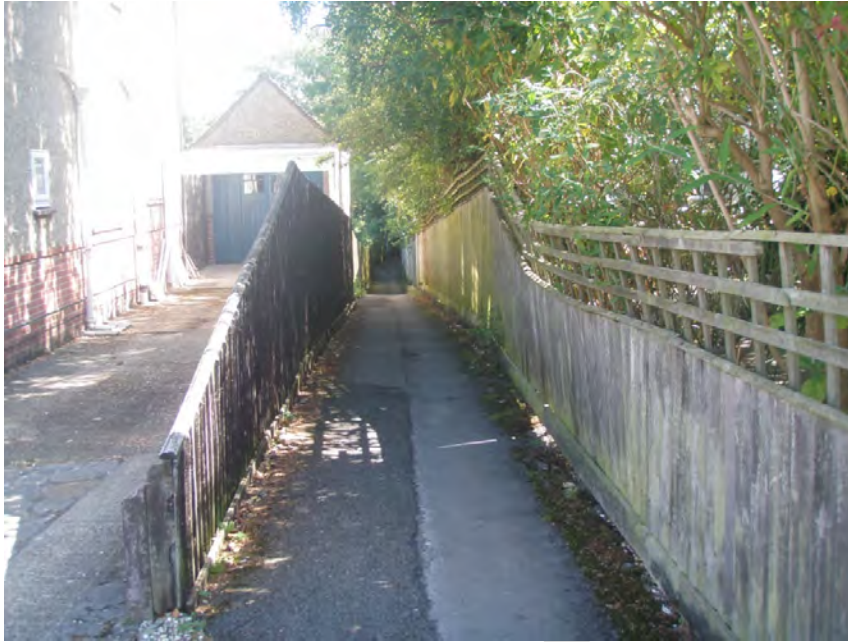
**Figure 5. Fencing and pathways river provide key connectivity of water from roads etc to the river (note the river location in this photograph is just beyond the trees and garage in the dip).**

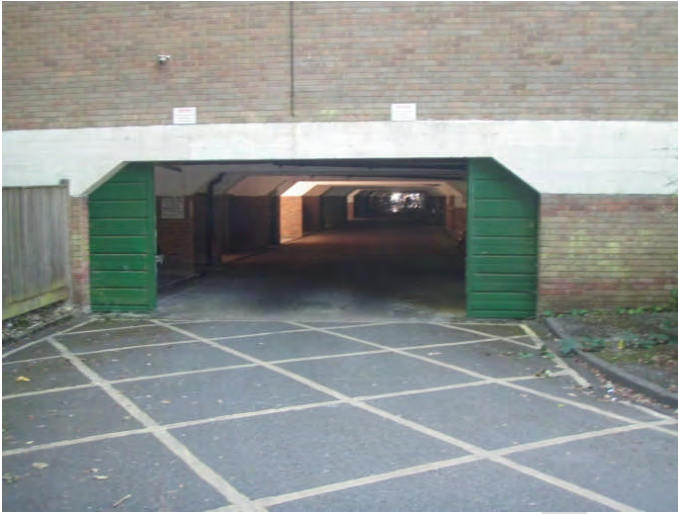
Figure 6. Garages situated under Grenville Court prevent fluvial flooding to properties above.

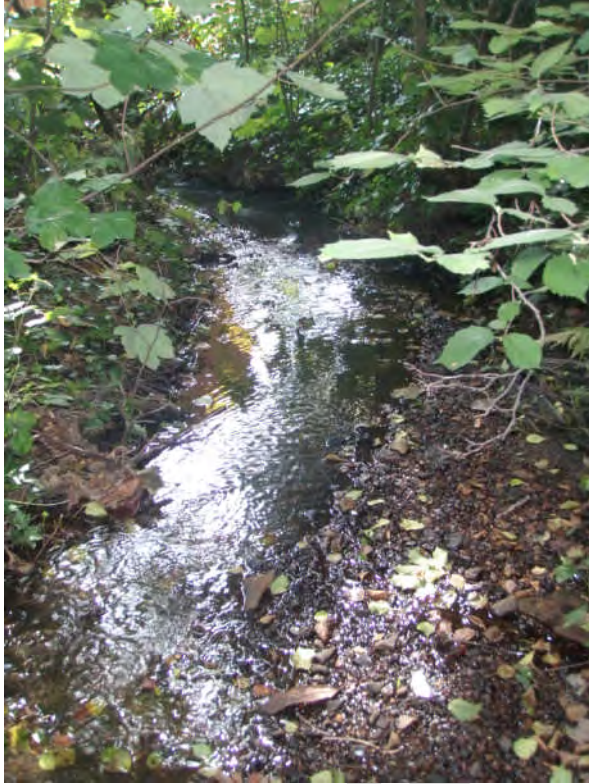
**Figure 7. Section immediately downstream of Grenville Court.**

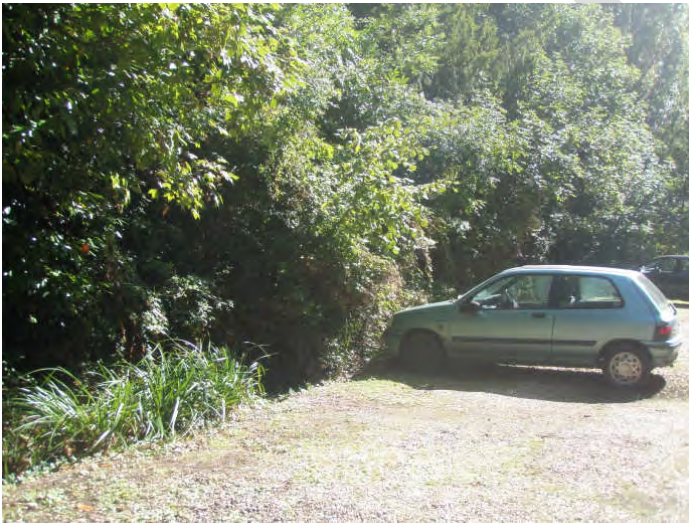
**Figure 10. Small drain running along the edge of car parking area.**

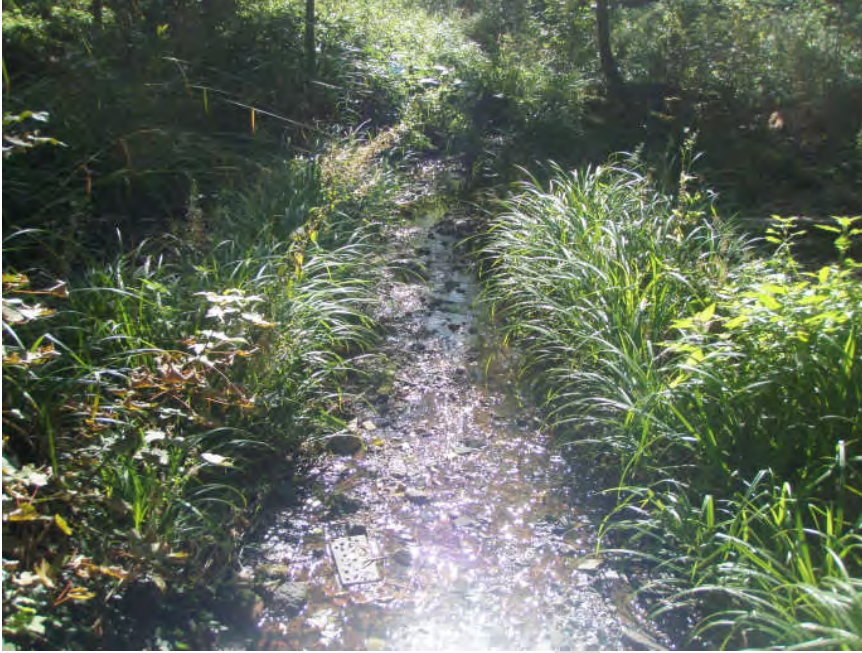
**Figure 13. Section with native marginal vegetation.**

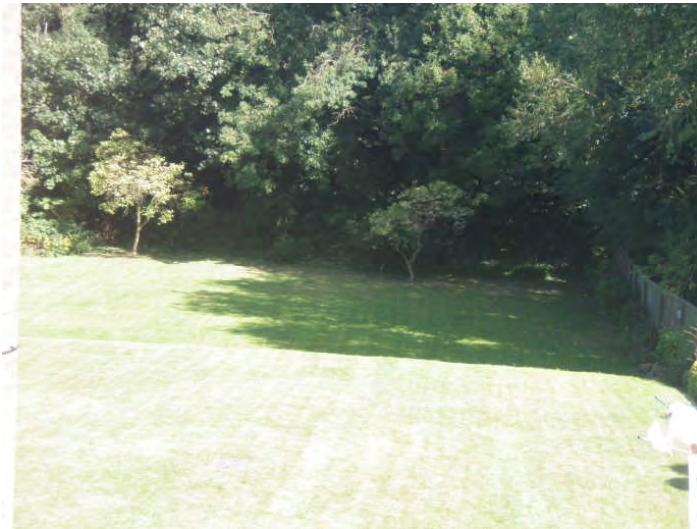
**Figure 14. Section of Rolles Brook considered for deculverting.**

should be cut. In addition earth works would be necessary to re-profile and re-landscape the communal garden area of this residential site; the project could quite conceivably cost in the region of £50K+. Any disturbed land comes with the risk of the growth of stands of Japanese Knotweed. In this location especially, given that the upstream section is choked with the weed and currently the trash screen is completely covered with Japanese Knotweed debris, the probability of contamination at the proposed restoration site is extremely high (Figure 15). Therefore it is recommended that before any deculverting of this section is considered eradication of Japanese Knotweed upstream is seen as a priority.

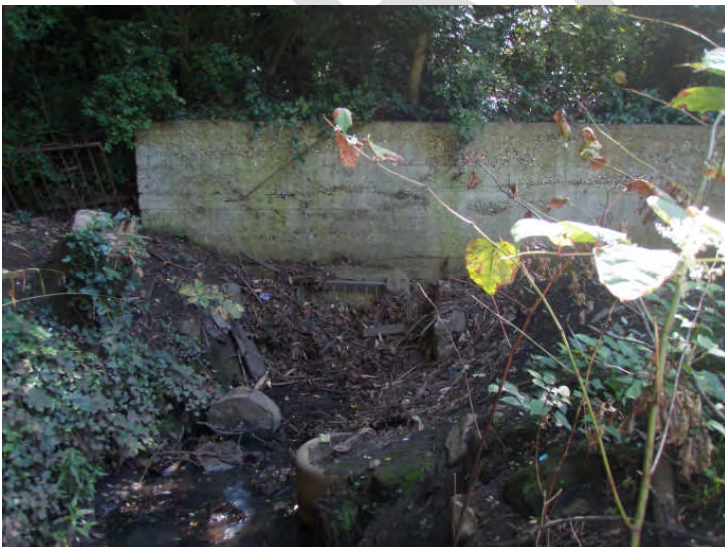
**Figure 15. Blocked trash screen with primarily with Japanese Knotweed debris.**

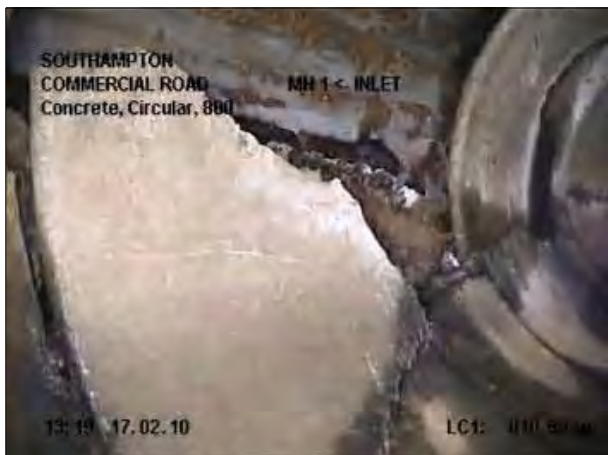
Photo: 10\_8a, Tape No.: 1  
10.6m, Sewer Broken, from 07 to 10 o'clock

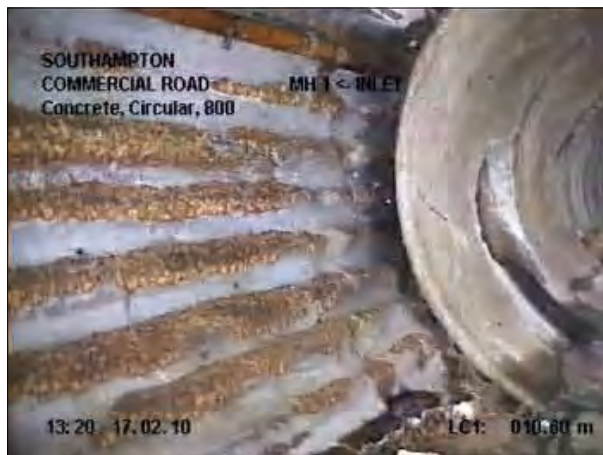
Photo: 11\_9a, Tape No.: 1  
10.6m, General Observation, Remark: REPAIR MADE

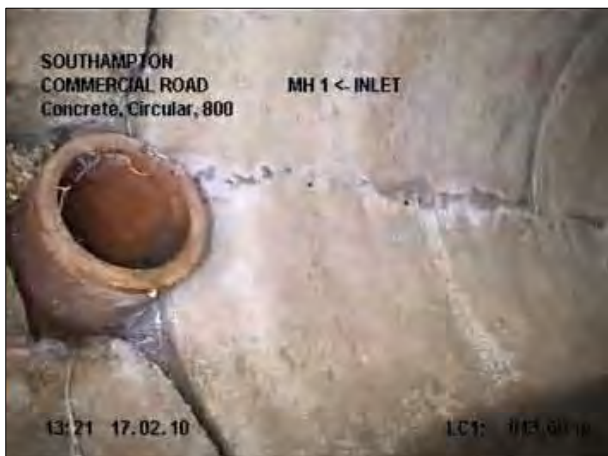
Photo: 14\_12a, Tape No.: 1  
13m, Connection, at 10 o'clock, dia 150 mm, intrusion 80 mm

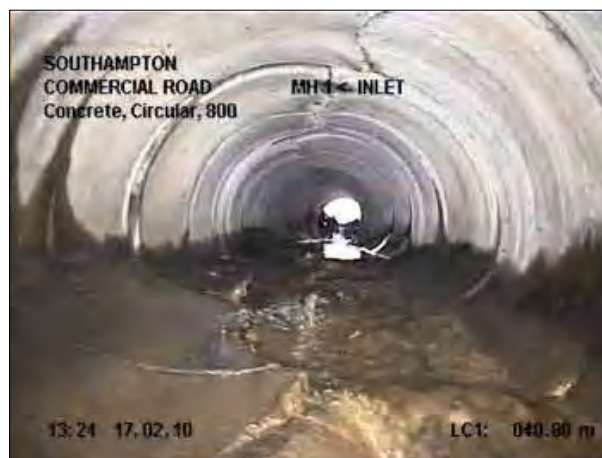
Photo: 21\_18a, Tape No.: 1  
40.8m, Sewer Broken, from 05 to 07 o'clock, Start

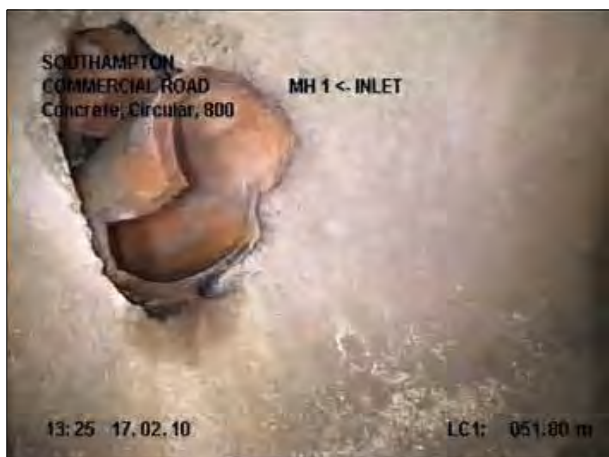
Photo: 24\_21a, Tape No.: 1  
51.8m, Connection defective, at 09 o'clock, dia 150 mm,  
intrusion  
150 mm

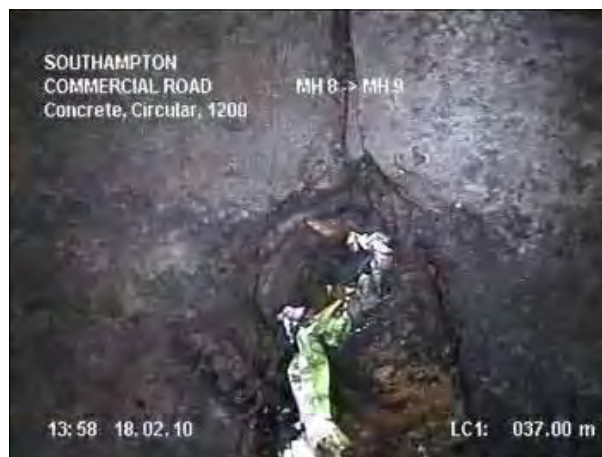
Photo: 107\_8a, Tape No.: 1  
37m, Connection defective, at 02 o'clock, dia 150 mm

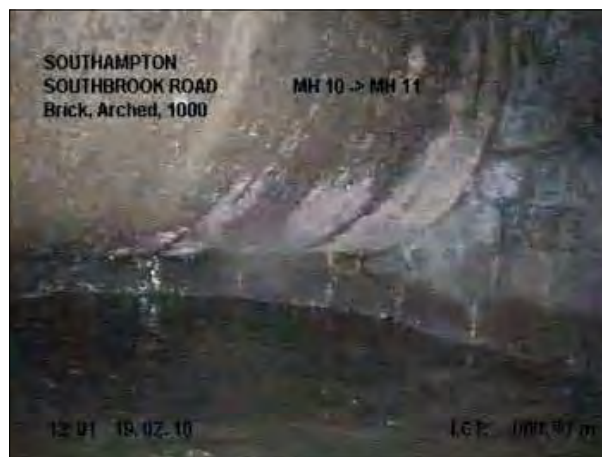
Photo: 131\_9a, Tape No.: 1  
0.9m, General Condition photograph, Remark: SERVICE PIPE PASSING THROUGH

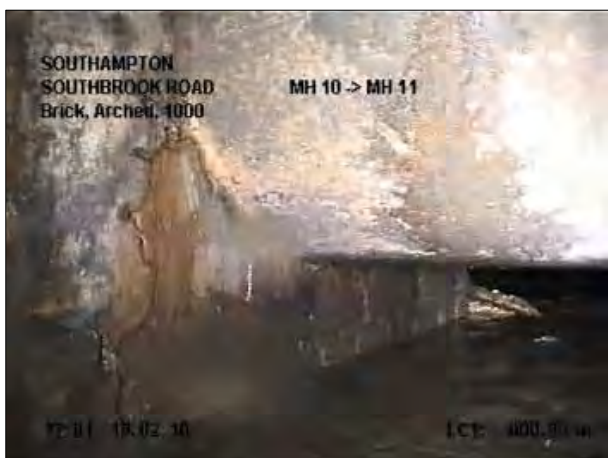
Photo: 131\_9b, Tape No.: 1  
0.9m, General Condition photograph, Remark: SERVICE PIPE PASSING THROUGH

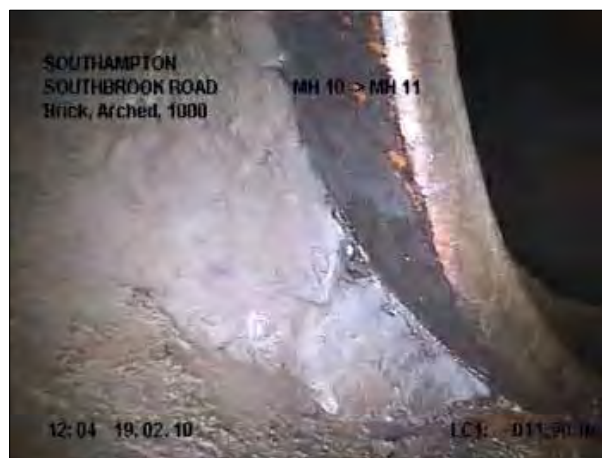
Photo: 11\_15a, Tape No.: 1  
11.9m, Connection, at 09 o'clock, dia 350 mm, intrusion 50 mm

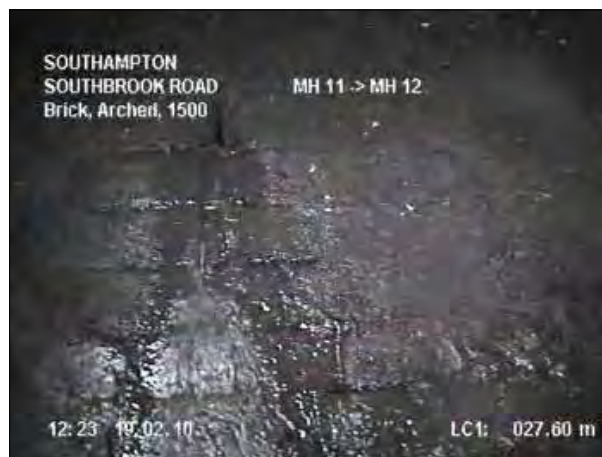
Photo: 158\_7a, Tape No.: 1  
27.6m, Infiltration Gushing from 08 to 10 o'clock
