## Appendix A – Data Received

## Appendix A1 Southampton SWMP: Data Collection Status

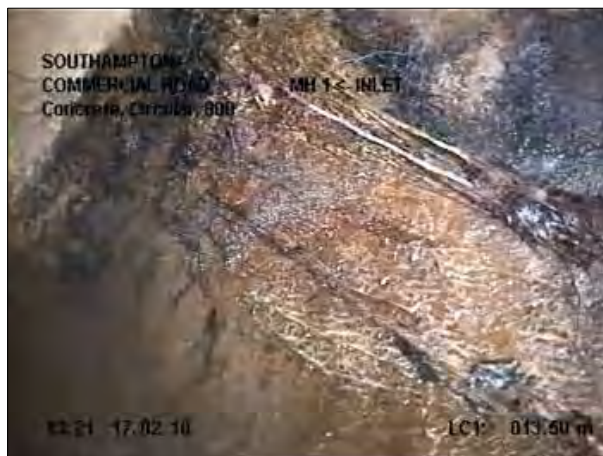
Photo: 15\_13a, Tape No.: 1  
13.5m, Mass Roots 10 % cross-sectional area loss

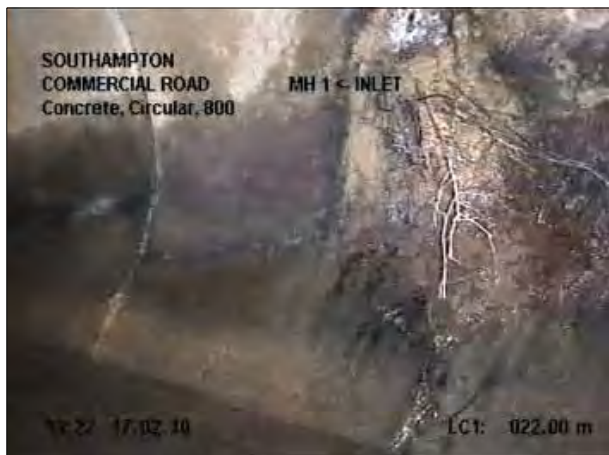
Photo: 16\_14a, Tape No.: 1  
22m, Mass Roots 10 % cross-sectional area loss

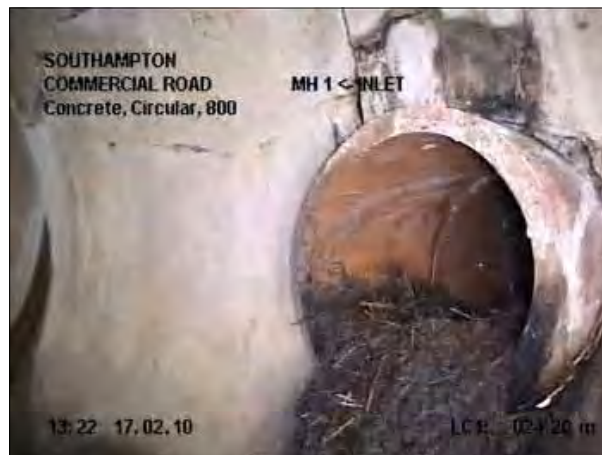
Photo: 17\_15a, Tape No.: 1  
24.2m, Connection, at 02 o'clock, dia 225 mm, intrusion 100 mm

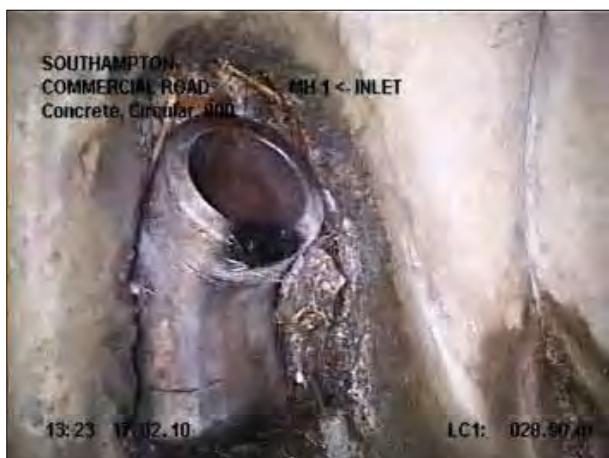
Photo: 18\_16a, Tape No.: 1  
28.9m, Connection, at 09 o'clock, dia 150 mm, intrusion 40 mm

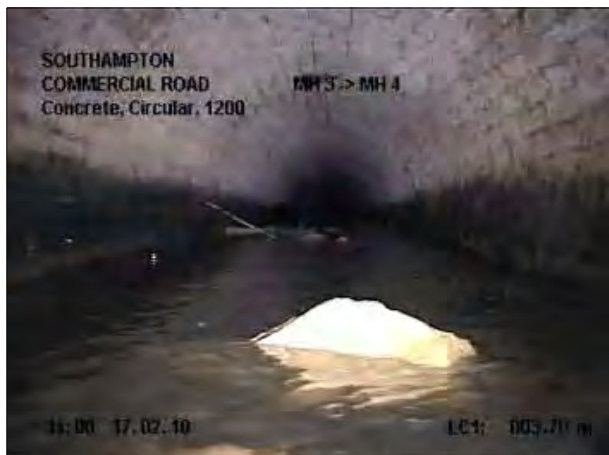
Photo: 47\_7a, Tape No.: 1  
3.7m, Obstruction, 30 % height/diameter loss

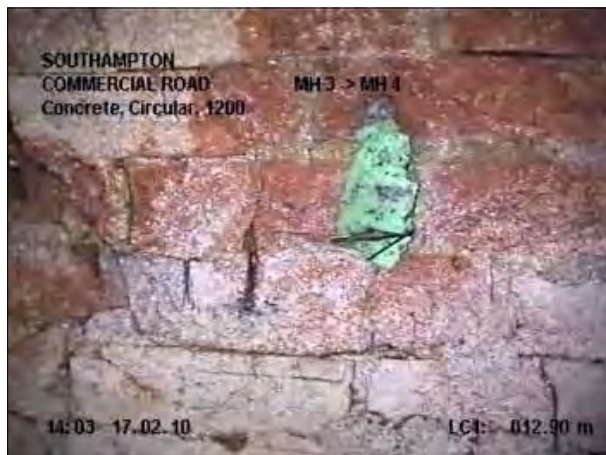
Photo: 49\_9a, Tape No.: 1  
12.9m, Hole in sewer from 01 to 02 o'clock

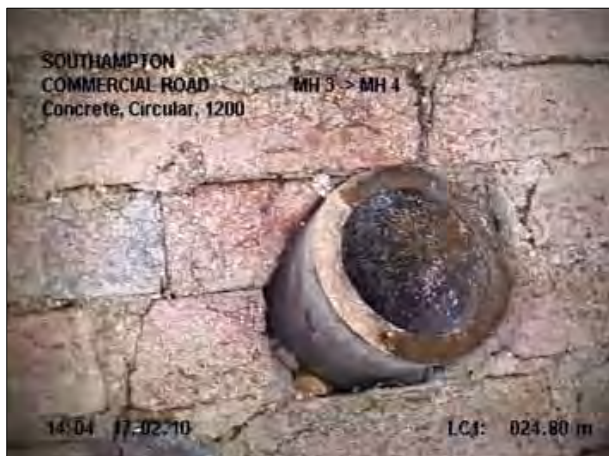
Photo: 51\_11a, Tape No.: 1  
24.8m, Connection, at 11 o'clock, dia 150 mm, intrusion 100 mm

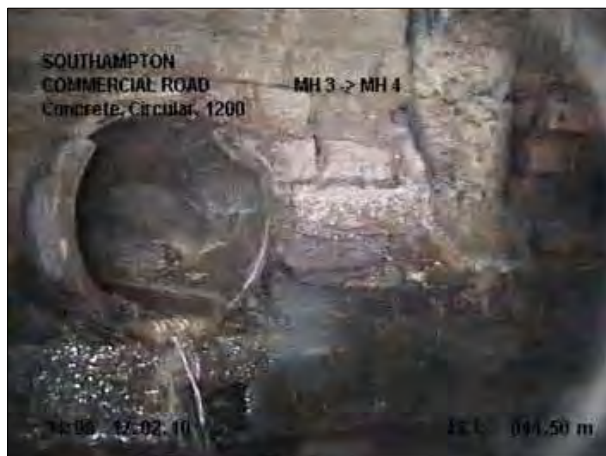
Photo: 53\_13a, Tape No.: 1  
44.5m, Connection, at 08 o'clock, dia 225 mm, intrusion 80 mm

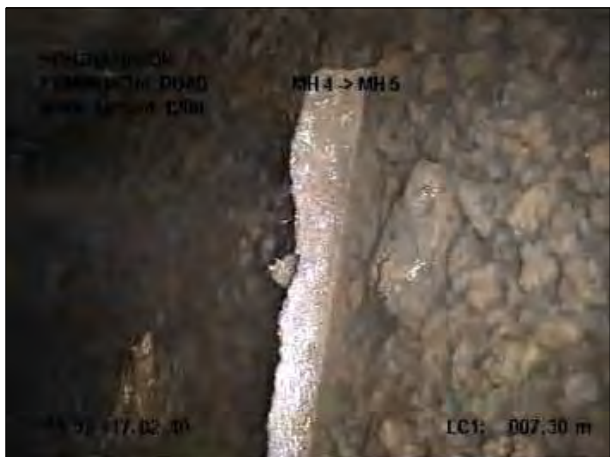
Photo: 62\_6a, Tape No.: 1  
7.3m, Obstruction, 30 % height/diameter loss

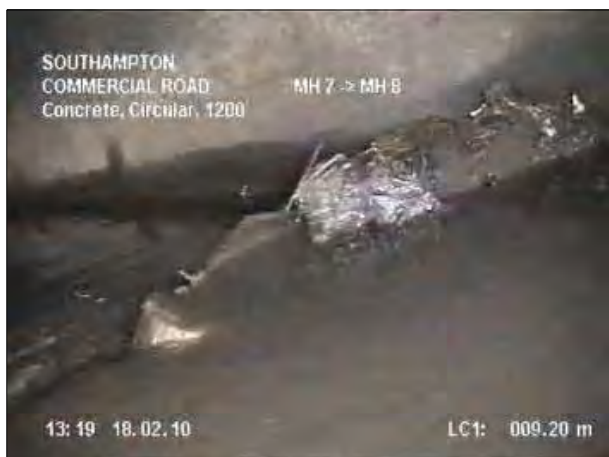
Photo: 88\_4a, Tape No.: 1  
9.2m, Obstruction, 30 % height/diameter loss

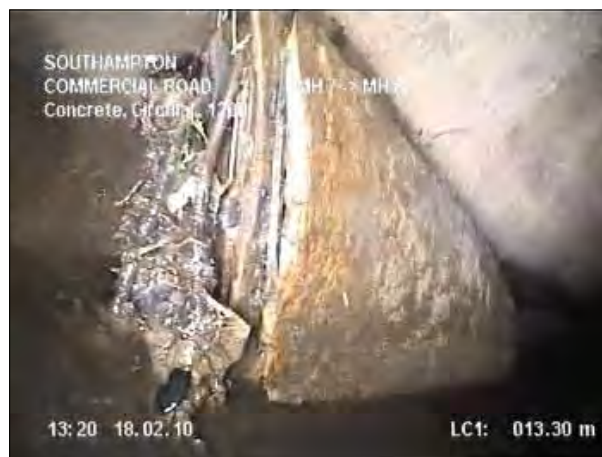
Photo: 89\_5a, Tape No.: 1  
13.3m, General Observation, Remark: WOODEN PLANKS

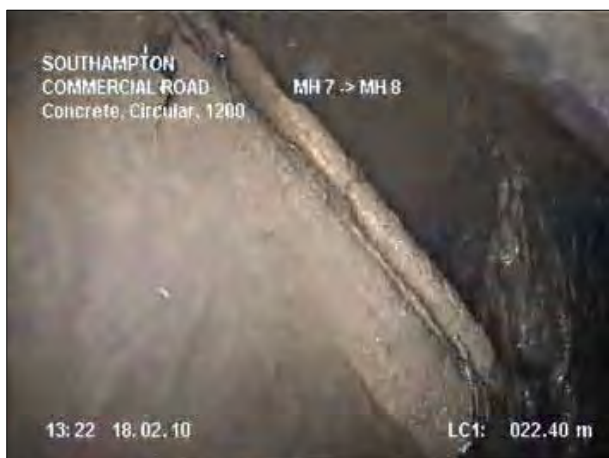
Photo: 92\_8a, Tape No.: 1  
22.4m, Obstruction, 20 % height/diameter loss

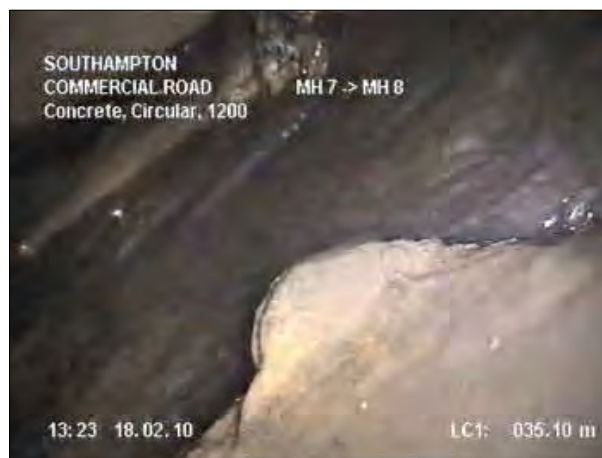
Photo: 93\_9a, Tape No.: 1  
35.1m, Obstruction, 30 % height/diameter loss

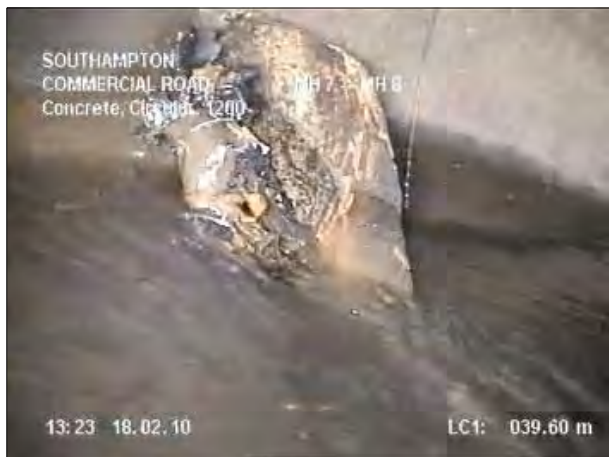
Photo: 94\_10a, Tape No.: 1  
39.6m, Obstruction, 30 % height/diameter loss

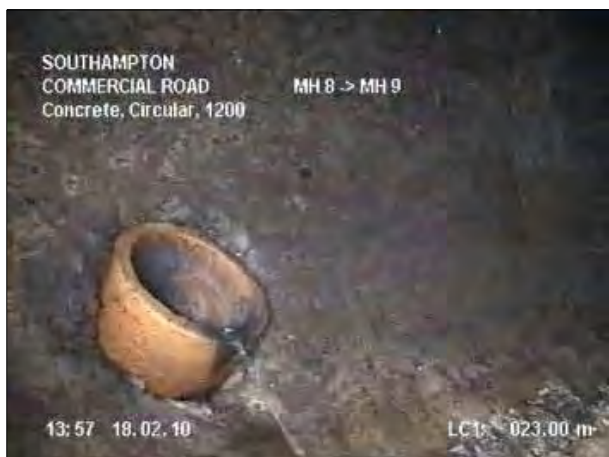
Photo: 106\_7a, Tape No.: 1  
23m, Connection, at 10 o'clock, dia 150 mm, intrusion 100 mm

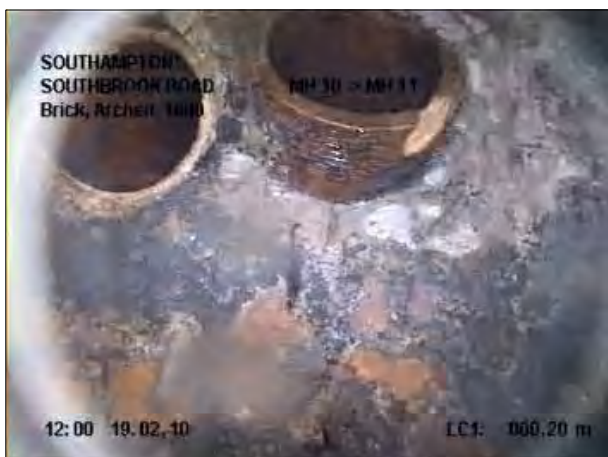
Photo: 128\_6a, Tape No.: 1  
0.2m, Connection, at 01 o'clock, dia 150 mm, intrusion 100 mm

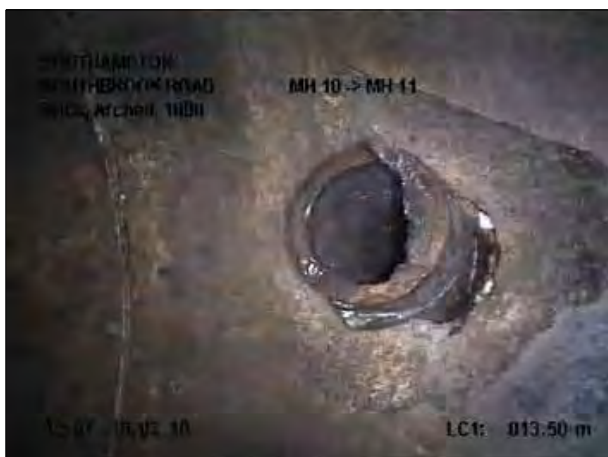
Photo: 11\_16a, Tape No.: 1  
13.5m, Connection, at 12 o'clock, dia 100 mm, intrusion 150 mm

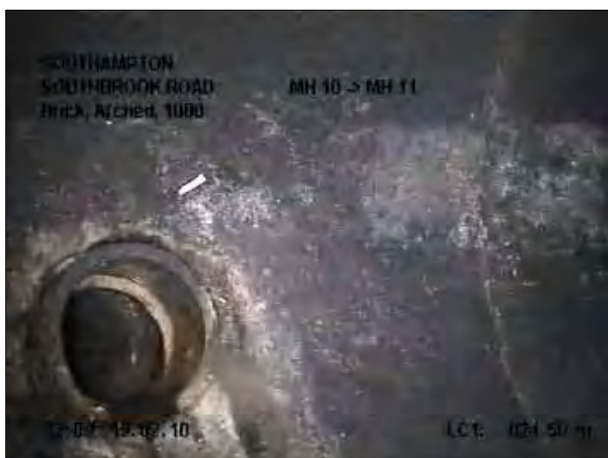
Photo: 11\_18a, Tape No.: 1  
24.5m, Connection, at 12 o'clock, dia 100 mm, intrusion 40 mm

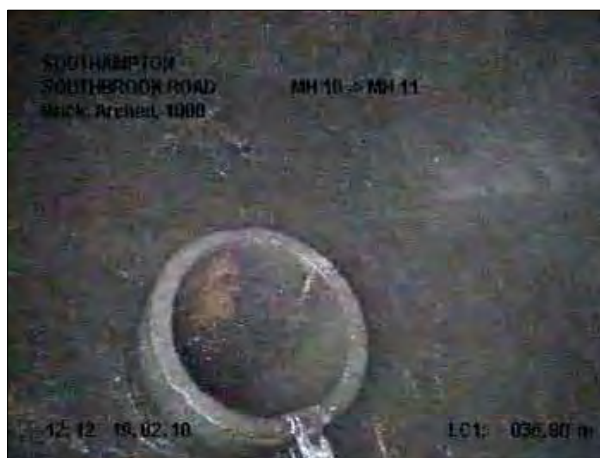
Photo: 146\_22a, Tape No.: 1  
36.8m, Connection, at 09 o'clock, dia 150 mm, intrusion 80 mm

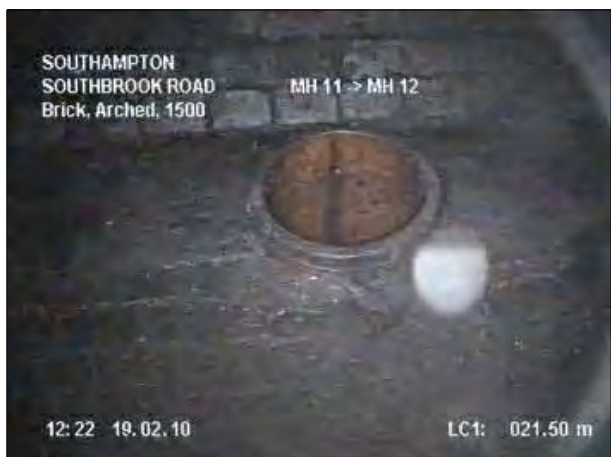
Photo: 157\_6a, Tape No.: 1  
21.5m, Connection, at 11 o'clock, dia 200 mm, intrusion 20 mm

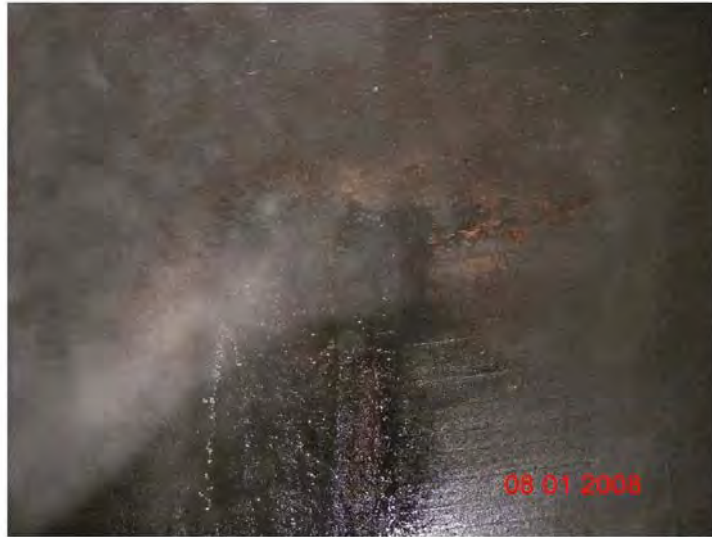
Water was found to be leaking from the sidewall on the Redbridge side over an area of 1m<sup>2</sup>.

Photograph No 3 Water seepage at -5000mm to 0mm

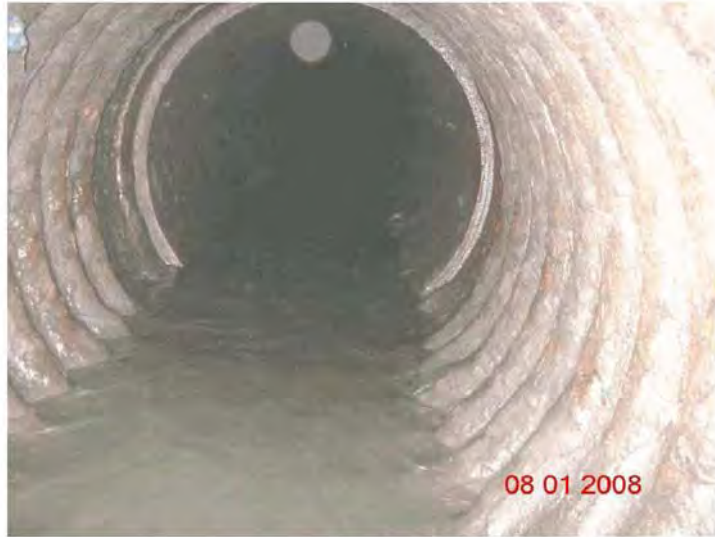
Photograph No 7 Corrugated Steel Section

There are no indications of holing, hollow patches, fracturing or deformation. (Photos 7 & 8)
