**Grenville Court, Southampton.**

Our operatives attended in order to carry out a full drainage CCTV survey. Please see below our findings with required repair costs and installation costs.

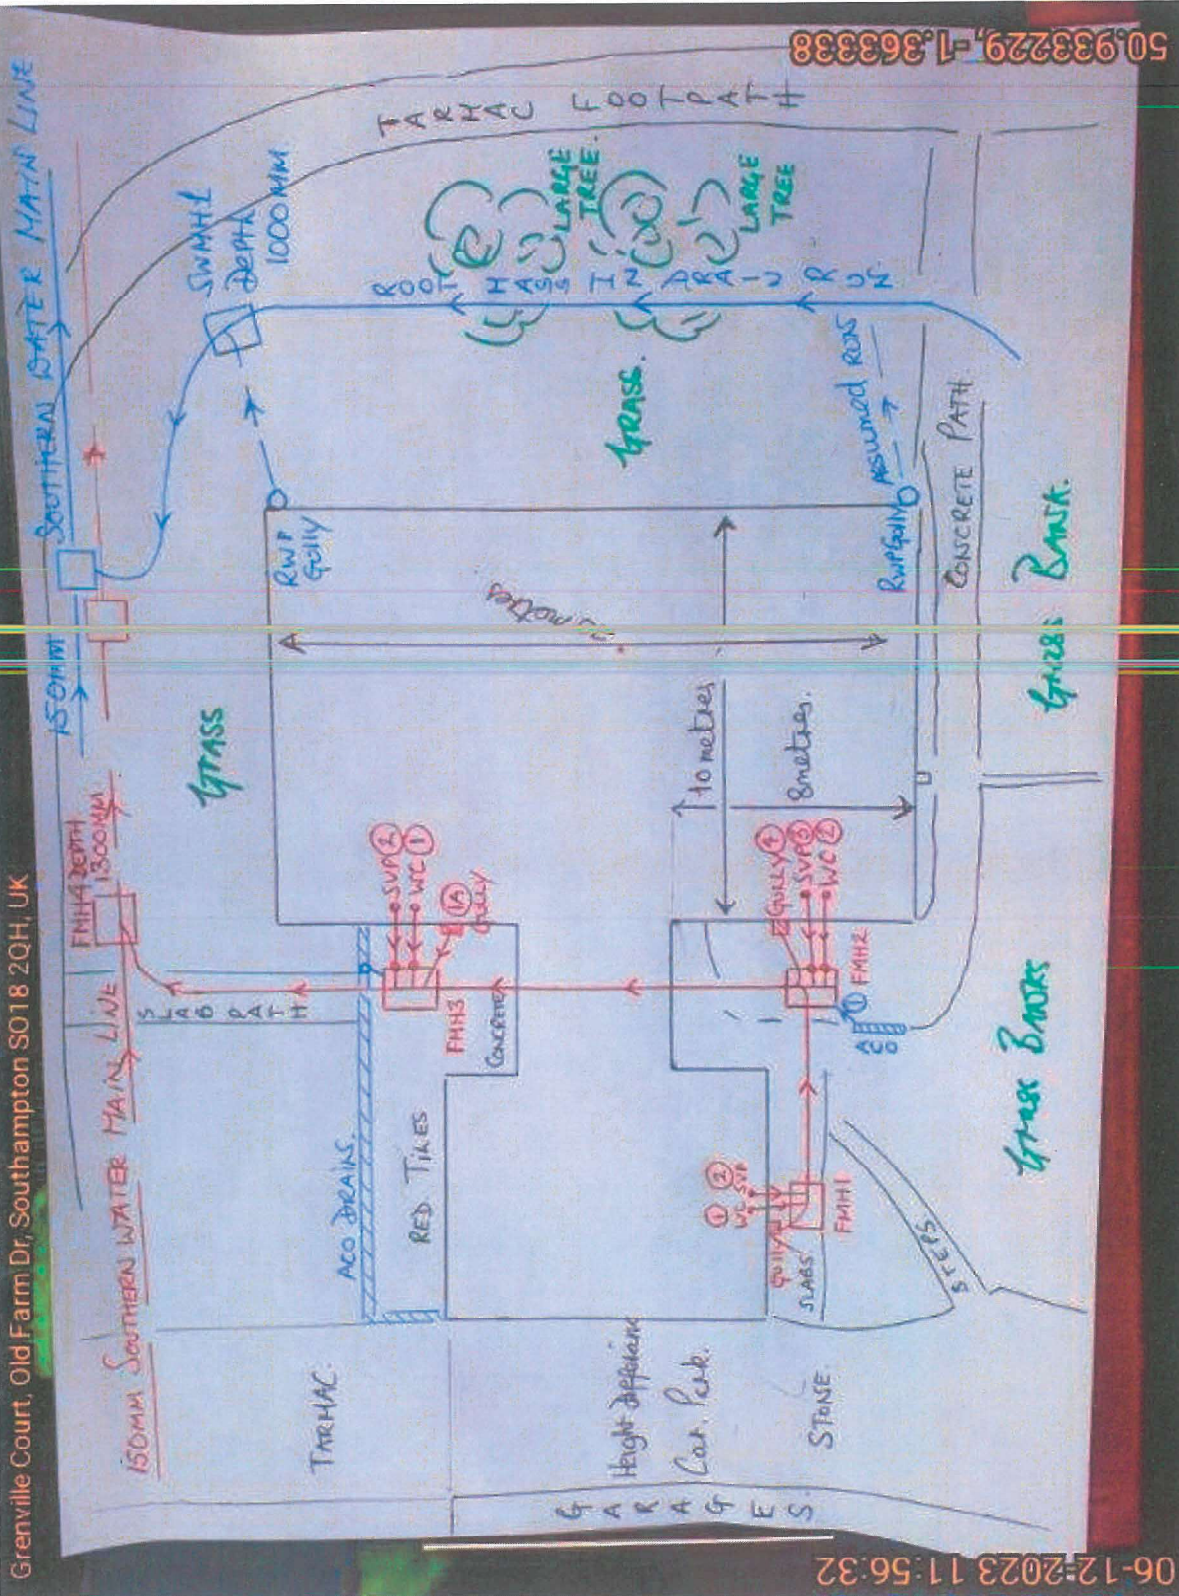
Southern Water MAIN LINE

Grenville Court, Old Farm Dr, Southampton SO18 2QH, UK
