## Appendix A – Data Received

## Appendix A1 Southampton SWMP: Data Collection Status

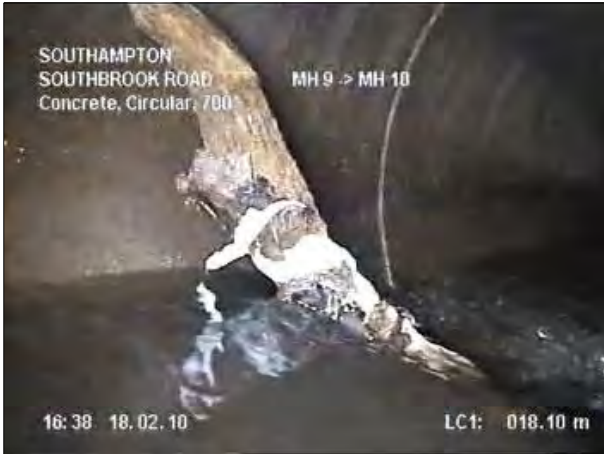
Photo: 117\_7a, Tape No.: 1  
18.1m, Obstruction, 40 % height/diameter loss, Remark: TREE  
TRUNK

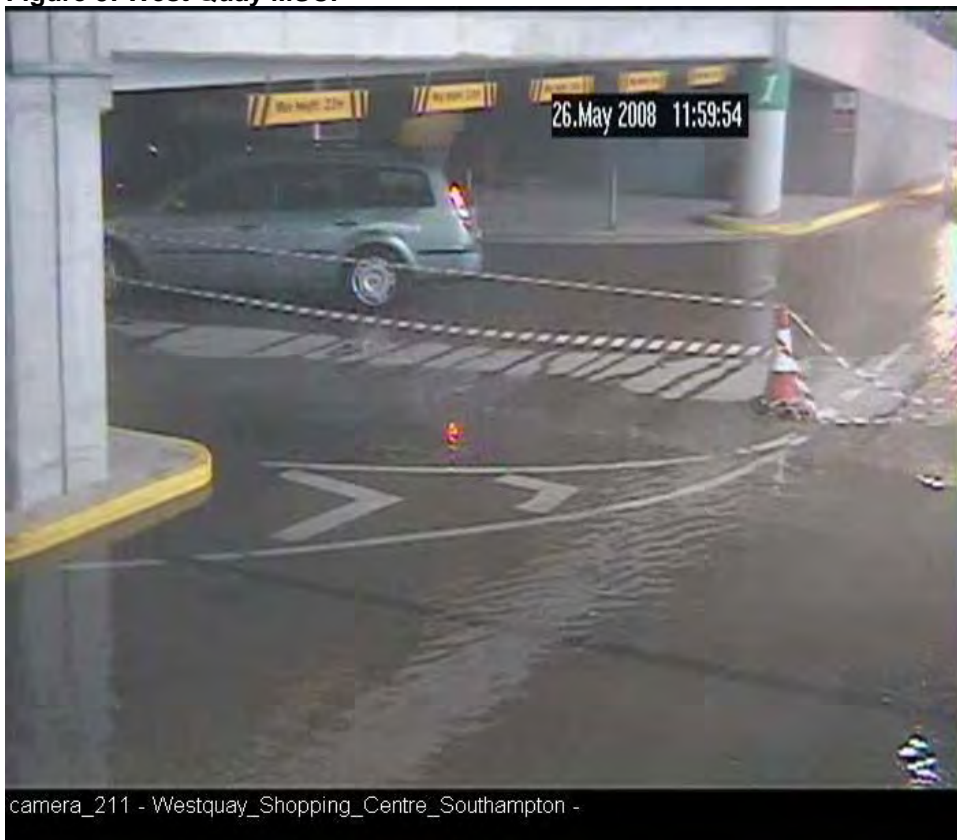
**Figure 6: MSCP flooding**
